Bobcat Flat RM 43 Phase II As-Built Monitoring Final Report

**Bobcat Flat RM 43 Phase II
As-Built Monitoring Final Report
(Including Phase I Monitoring and Analysis)**

Friends of the Tuolumne, Inc.
1900 NE 3rd Street, Suite 106#314
Bend, OR 97701

McBain and Trush, Inc.
P.O. Box 663
Arcata, CA 95518

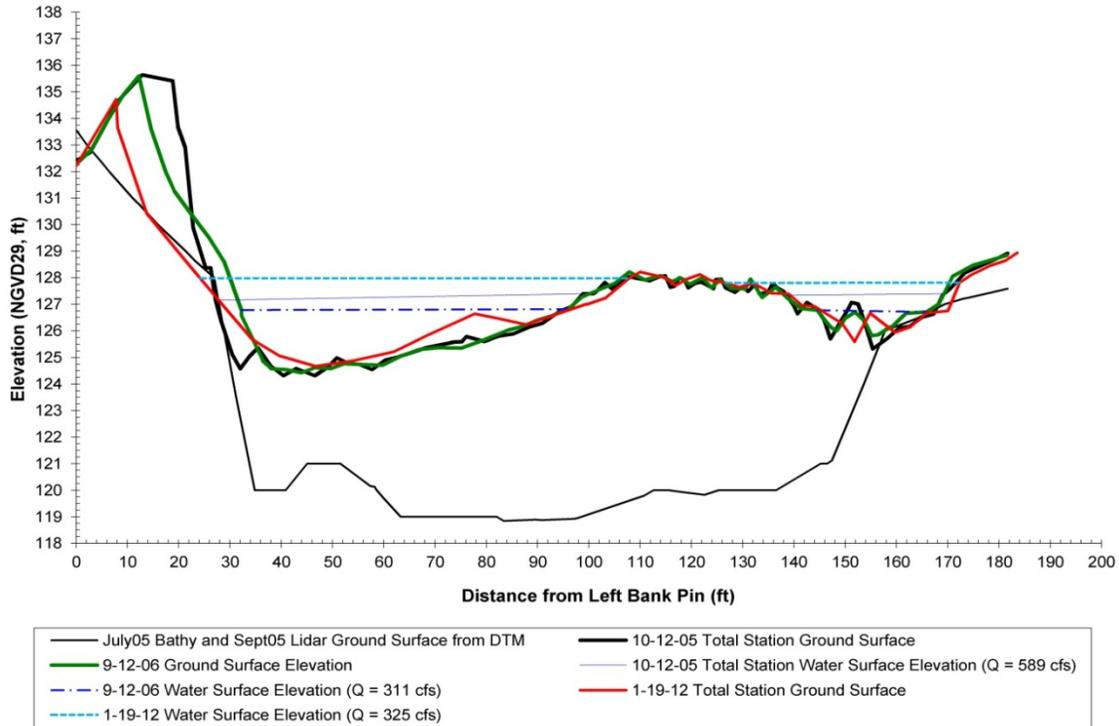
Figure 12. Cross section 2394+00 showing little to no change to Patch 6 as a result of Phase II construction activities. Patch 6 was used to provide access to Patch 8 and was graded post-construction to reduce compaction impacts from heavy equipment driving over the riffle.

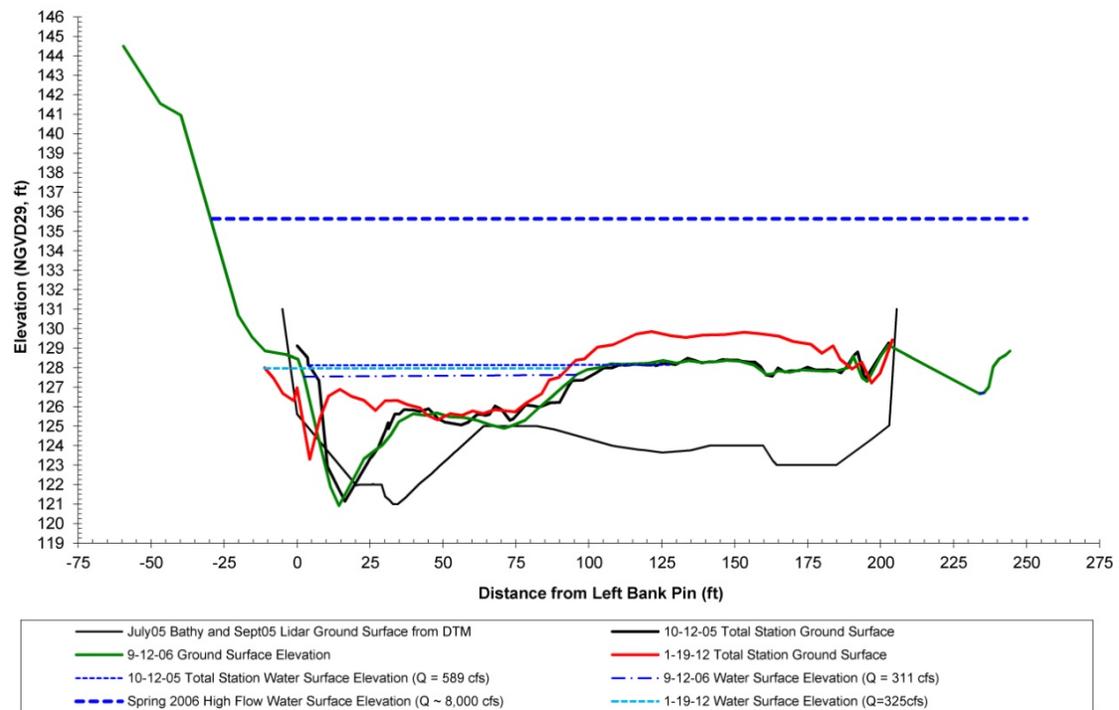
Figure 13. Cross section 2395+90 showing the continued development of the natural riffle across from Patch 5 and the 1-2 feet of material spread out over Patch 5 after Patches 7A, 7B, and 8 were completed.

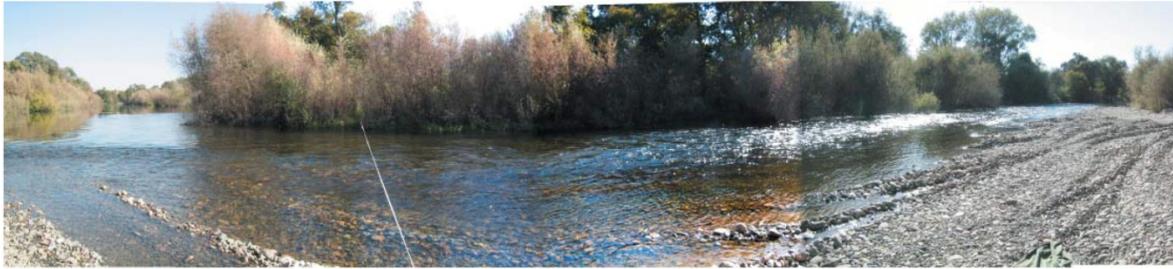
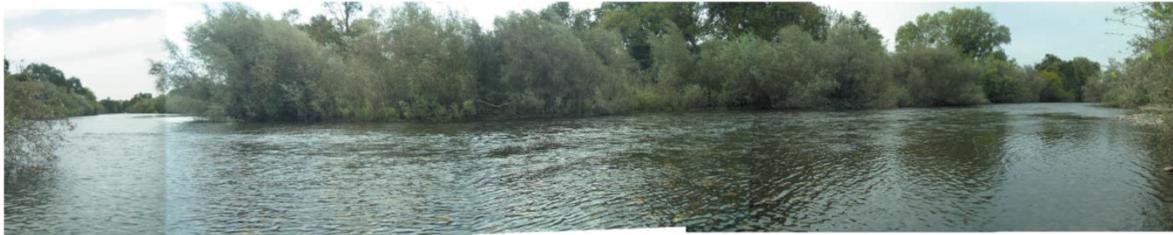
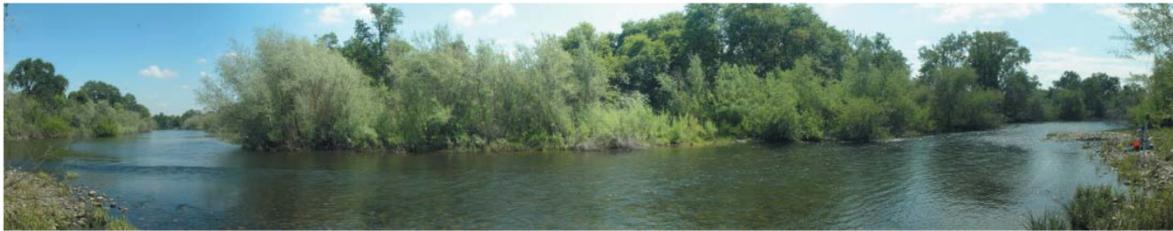
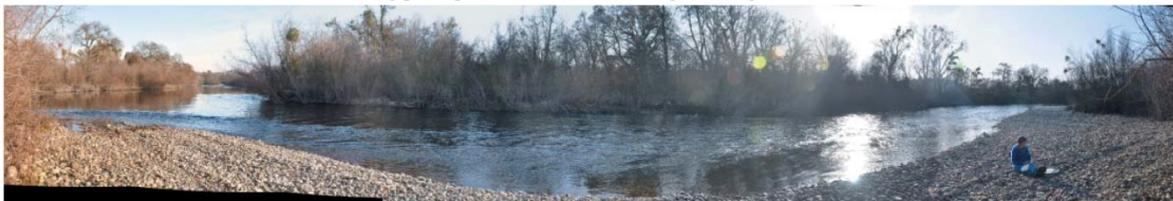
Figure 18. Photopoint #1, located at the middle of Patch 2. Photo monitoring shows the effectiveness of Patch 2 as a high flow coarse sediment recruitment source between 2005 and 2009. The top photo was taken in October of 2005 just after the construction of Patch 2 and the middle two photographs were taken after the 2006 high flows. The bottom photo was taken to document post-Phase II construction, note the similarities between the top and bottom photos.

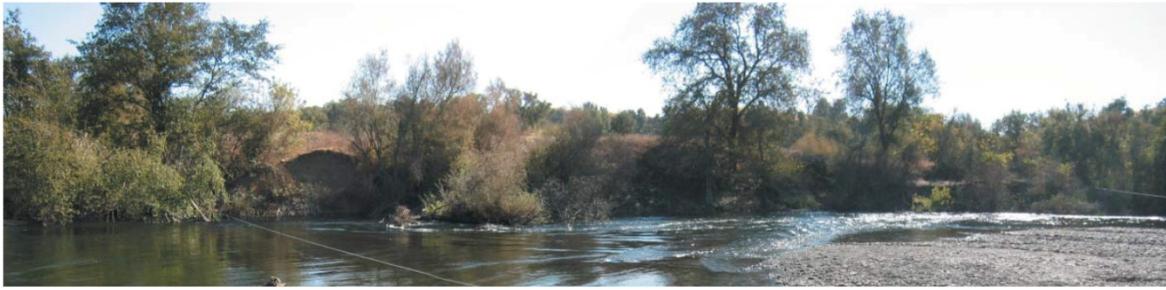
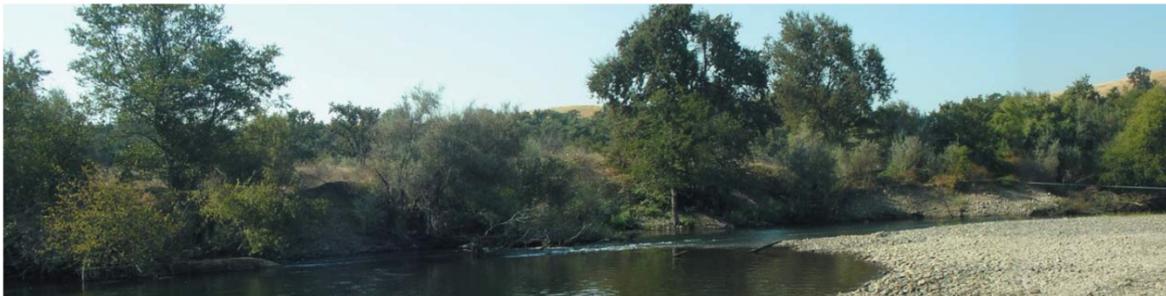
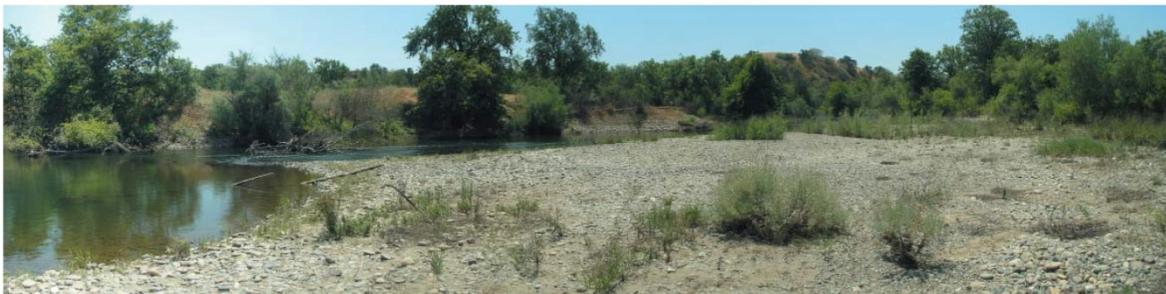
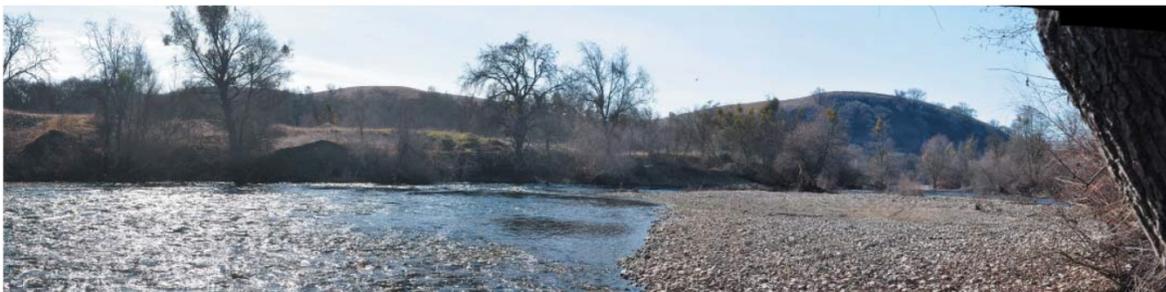
Figure 20. Photopoint #5 located at the upstream end of Patch 5. Photos indicate changes to Patch 5 as a result of high flows (2006) and fine sediment deposition (2009). The post-Phase II construction photograph also captures the 1 to 2 feet of coarse sediment placed at the upstream end of Patch 5 (shown in cross section 2395+90, Figure 13) to facilitate construction of Patches 7A and 7B.

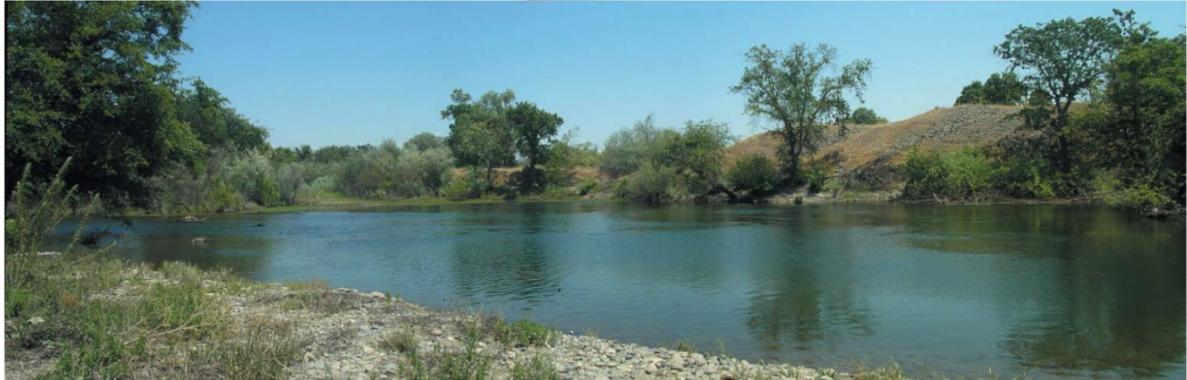
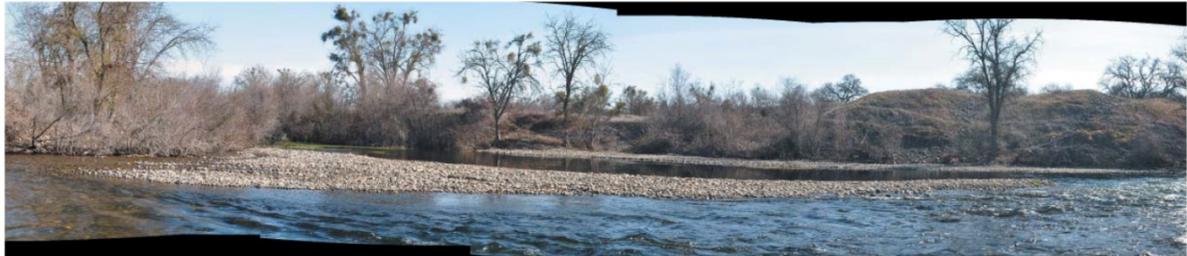
Figure 21. Photopoint #5 located at the upstream end of Patch 5, looking from right to left bank at Patches 7A and 7B. Note the additional low flow channel confinement and increased channel velocities associated with the construction of Patch 7A.

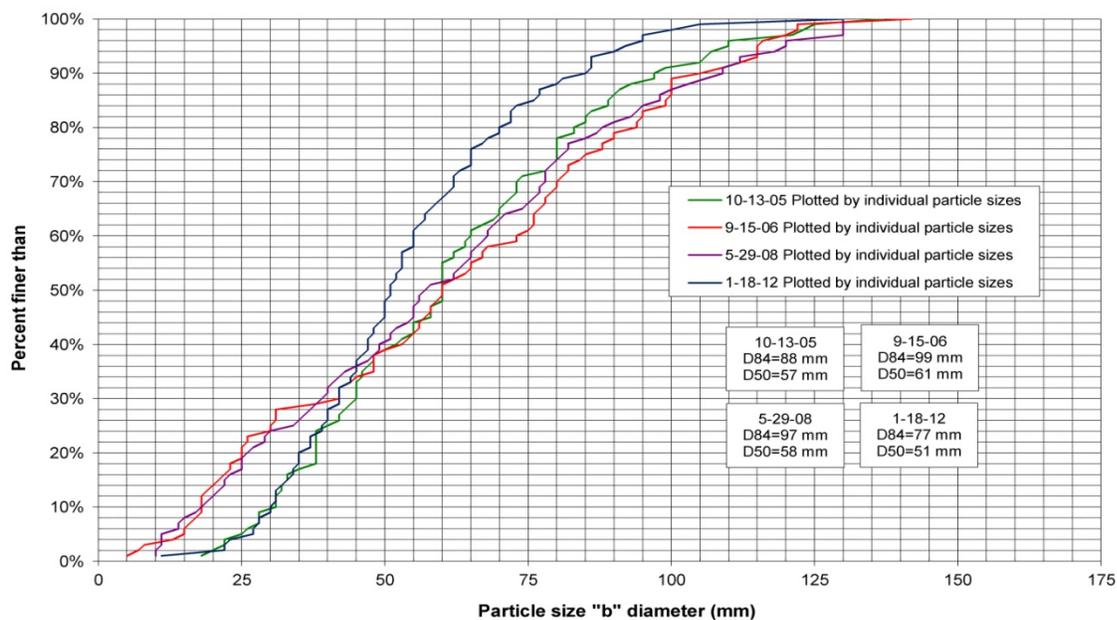
As-built monitoring pebble counts at Patches 2 and 10 were ranked by grain size and plotted (Figure 30 and Figure 31). A comparison of Phase I (2005) and Phase II (2012) Patch 2 as-built pebble counts indicates that above the 35 mm particle size, coarse sediment placed in 2012 was finer than that placed in 2005 (Figure 30). This change is a direct result of the use of 4 in x 4 in square screen during Phase II construction as opposed to the 5 in x 5 in screen used during Phase I construction. The Bobcat Flat RM 43 – Phase I As-Built Monitoring Final Report recommended the use of a 4 in x 4 in screen for future Bobcat Flat restoration phases (M&T 2006a).

Figure 30. Summary of Patch 2 pebble count results starting with Post-Phase I construction in October, 2005 and ending with Phase II as-built in January, 2012.

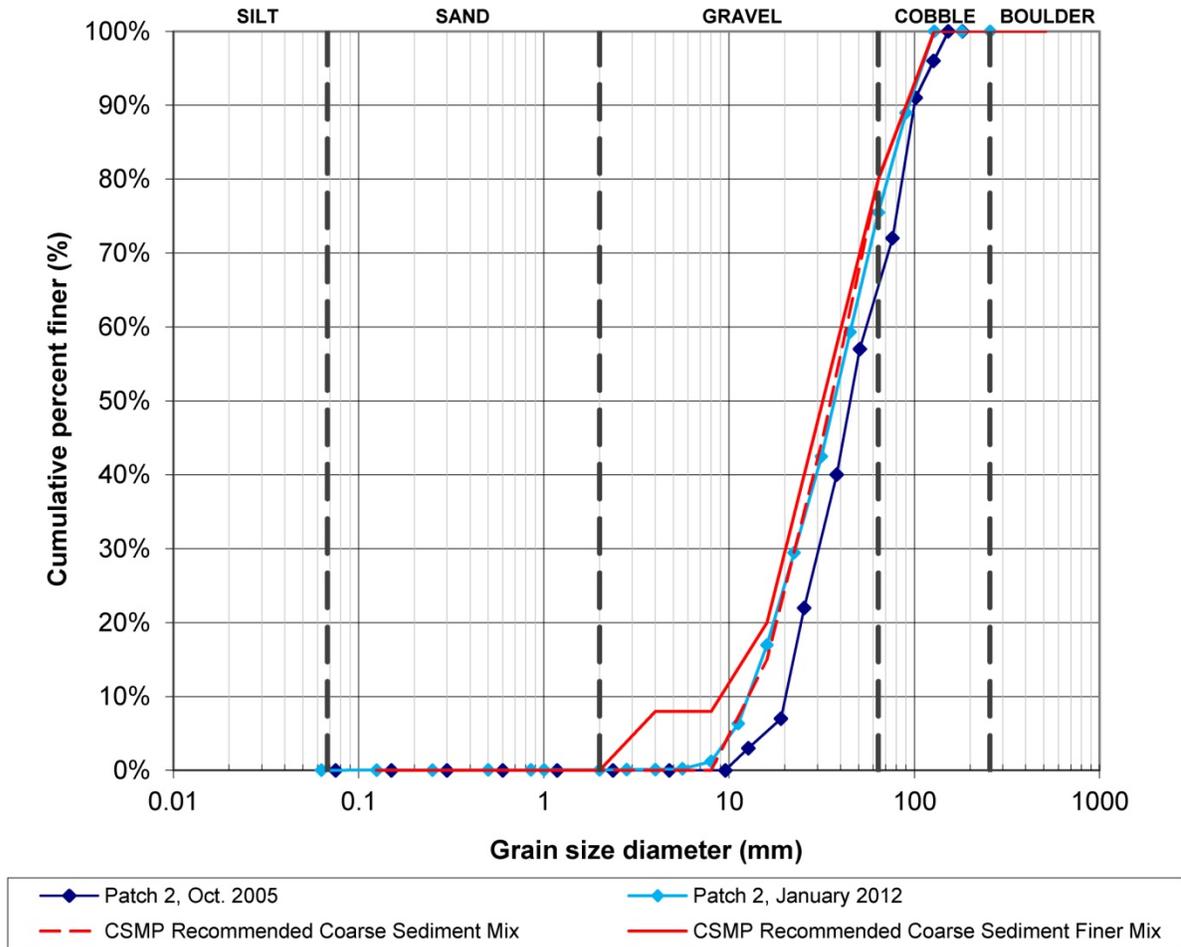
Bulk sample results for Patch 2 were plotted and provide a comparison between Phase I and Phase II as-built conditions (Figure 34). Flows in excess of 6,000 cfs mobilized most of the Phase I coarse sediment placed at Patch 2 to places downstream (Figure 18, M&T 2006). Therefore, only two bulk samples have been collected at Patch 2, one in 2005 and one in 2012 (Figure 2). The results show a finer coarse sediment was added during the Phase II construction, this is likely due to the use of a 4 x 4 inch upper screen size verses the 5 x 5 inch upper screen size used in the 2005 Phase I construction (Figure 34). The resulting coarse sediment added to Patch 2 during Phase II construction closely matches coarse sediment size recommendations from the Tuolumne River Coarse Sediment Management Plan (CSMP, M&T 2004) (Figure 34).

Figure 34. Patch 2 summary of bulk sample results for Phase I and Phase II as-built conditions compared to the recommended coarse sediment mix presented in the Tuolumne River Coarse Sediment Management Plan (M&T 2004).

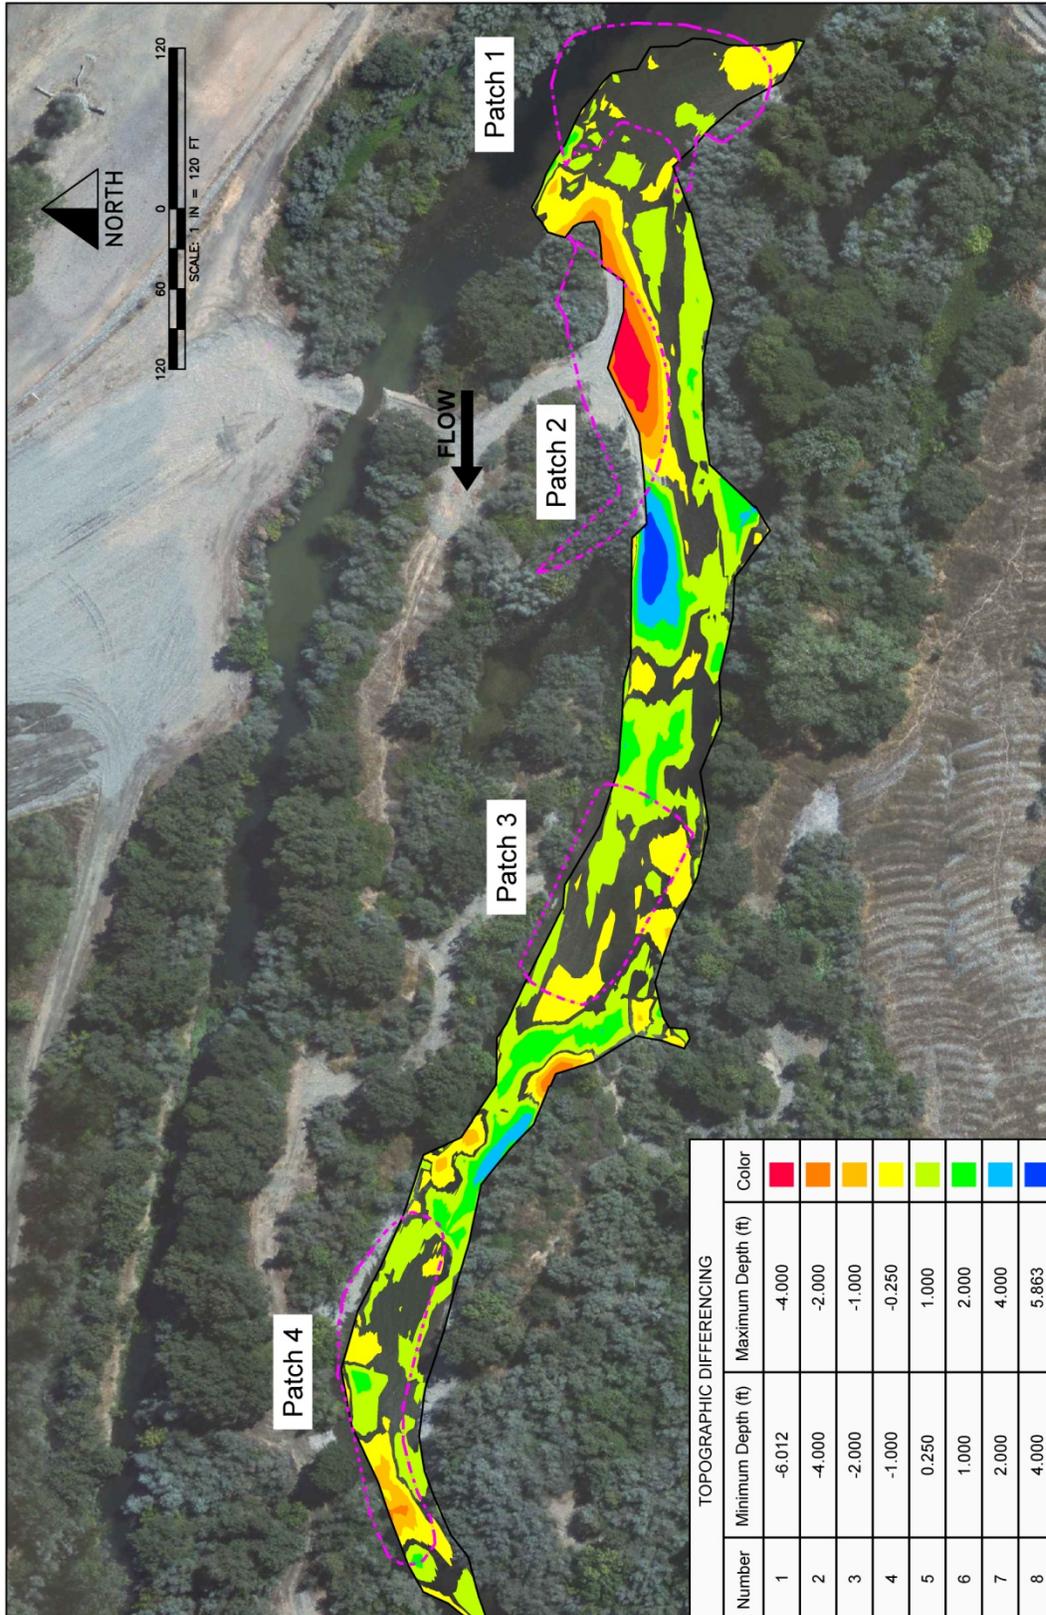
Figure 37. Topographic differences at Phase I Patches 1 through 4 showing feet of deposition and scour between 2006 and 2011 as a result of flows in excess of 6,000 cfs (Figure 10).

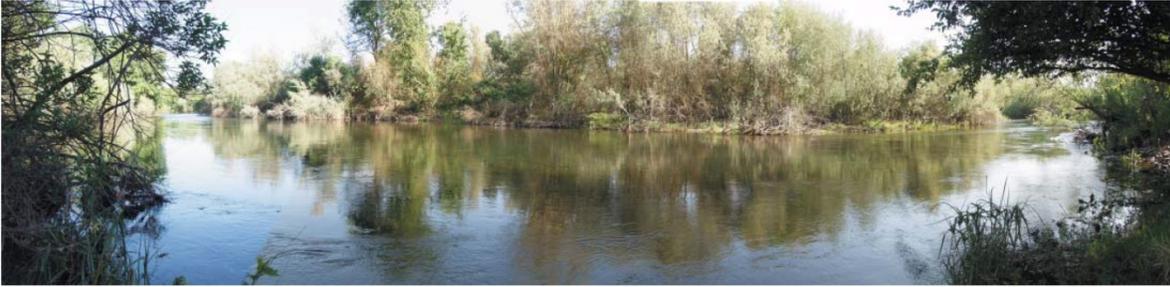
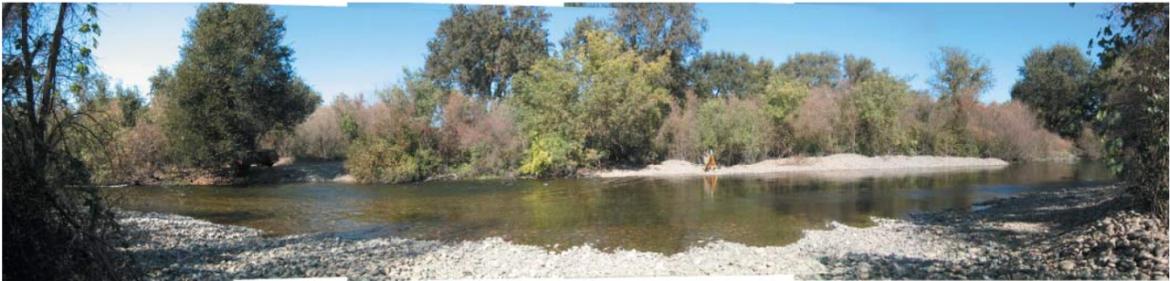
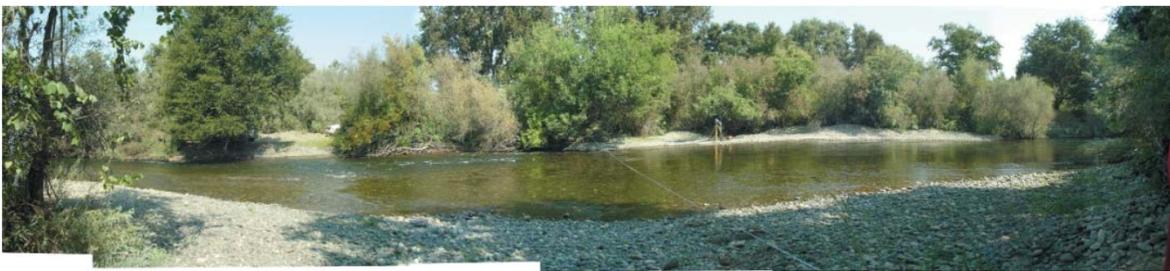
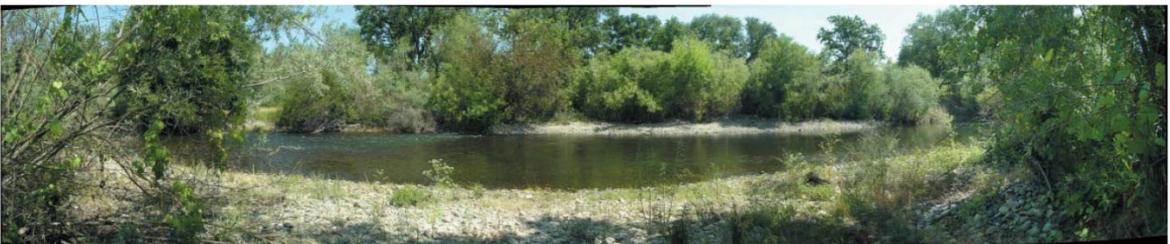
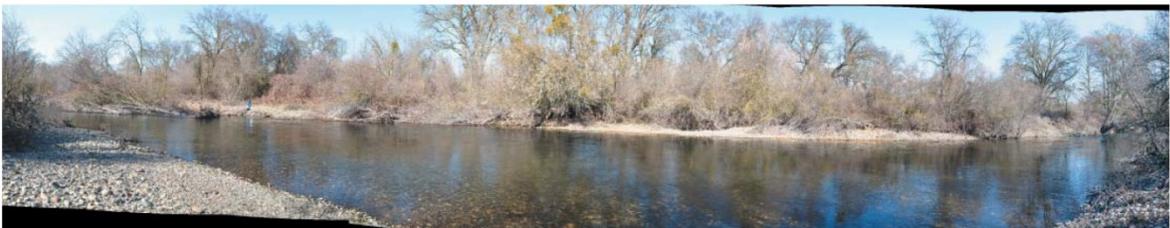
Figure 46. Photopoint #3, located at the middle of Patch 4 along the left bank. Photo monitoring shows the effectiveness of coarse sediment along with high flows at reworking bank and recruitment of large wood.

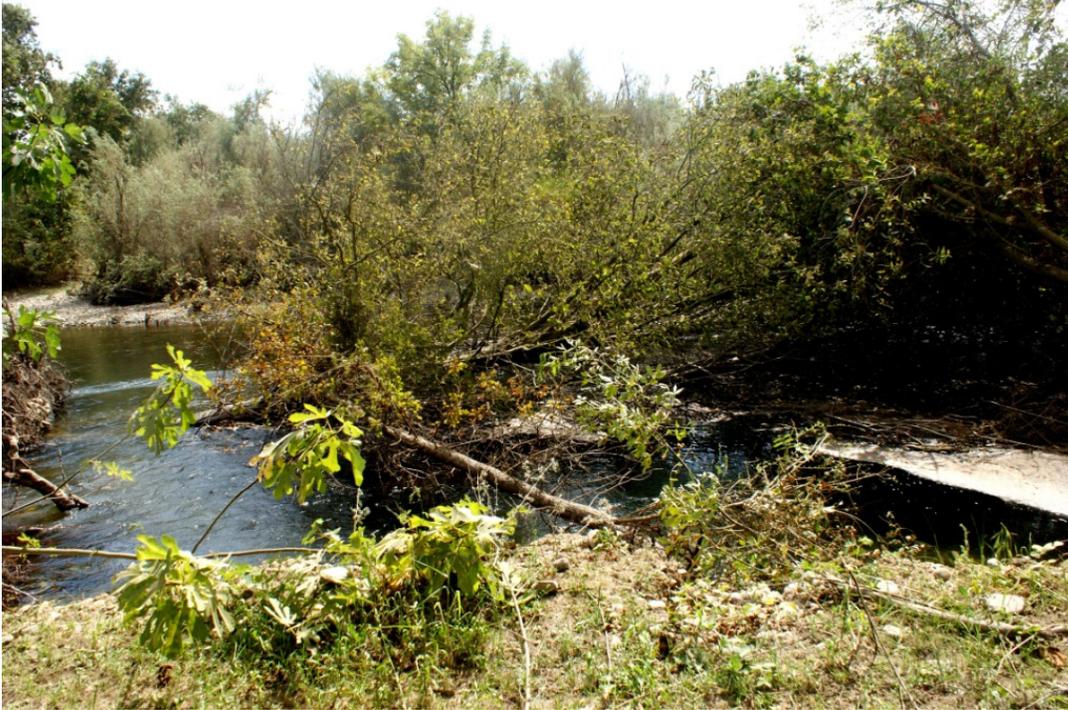
Figure 47. Large alder along the right bank opposite Patch 4 left bank bar, recruited by 2011 high flows, showed deposition upstream and scour adjacent to and downstream of the fallen tree (Figure 37).
