Bobcat Flat RM 43 Phase II As-Built Monitoring Final Report

**Bobcat Flat RM 43 Phase II
As-Built Monitoring Final Report
(Including Phase I Monitoring and Analysis)**

Friends of the Tuolumne, Inc.
1900 NE 3rd Street, Suite 106#314
Bend, OR 97701

McBain and Trush, Inc.
P.O. Box 663
Arcata, CA 95518

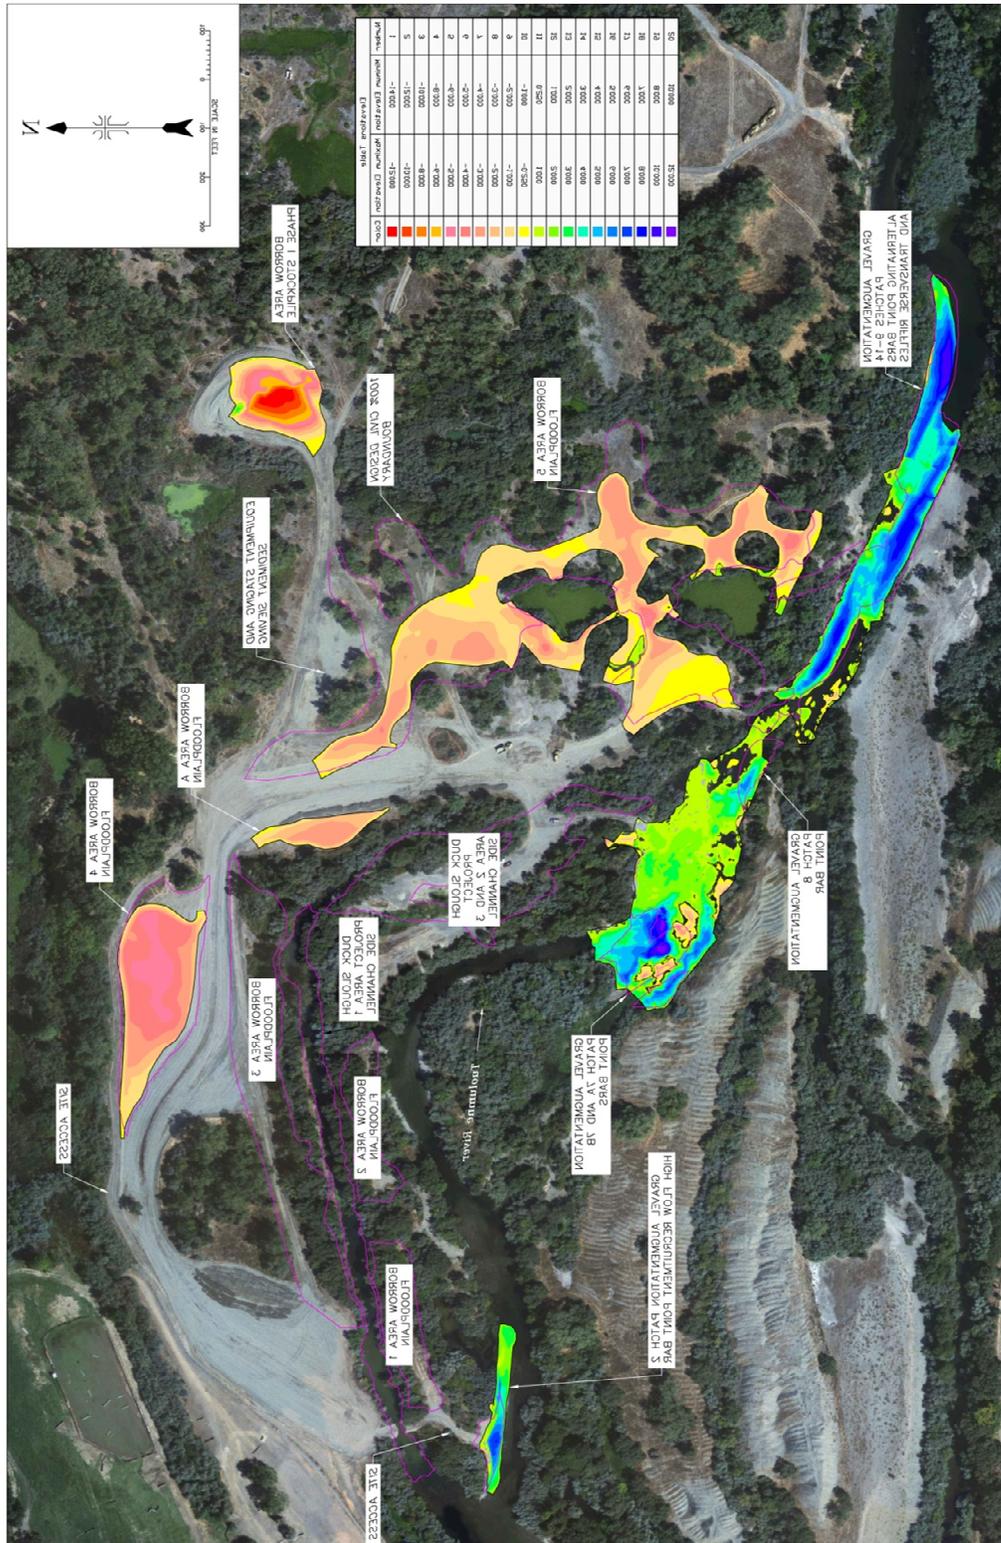
Figure 9. Planform map showing as-built topographic differencing between pre-construction and as-built topography and 100% design boundary and as-built boundary overlaid on the 2005 aerial photograph.

The resulting topographic differencing from the 2011 Phase II construction shows the cut/fill surface, in 1-foot vertical colored increments (Figure 9). The greatest excavation depth occurred within the existing stockpile area (12 to 14 ft) and Borrow Area 4 (5 to 6 ft) while the greatest fill areas occurred within Project Areas 7A and 14 (10 to 12 ft). The cut/fill volumes are summarized in Table 1 and Table 2. Figure 9 also shows a few areas of cut between Patches 7A and 7B. Since no material was removed from the channel, the difference was determined to be a result of the 2005 bathymetry data used for this portion of the pre-construction topography. Flows in excess of 6,000 cfs in 2006 and 2011 (Figure 10) are most likely the cause of this topographic difference.

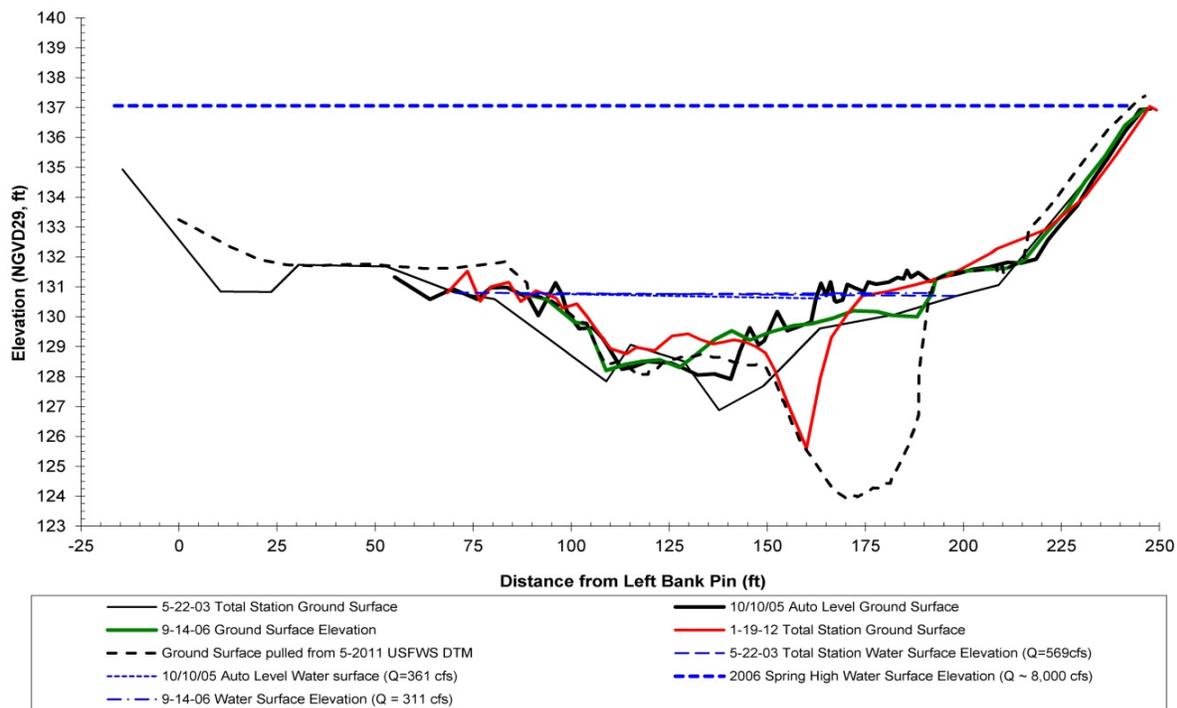
Figure 11. Cross section 2412+10 showing 2003 existing site conditions, Phase I as-built topography 2006 and 2011 site conditions, and Phase II as-built topography.

Results for the three cross sections and longitudinal profiles surveyed as part of the Phase II as-built monitoring are shown in Figure 11 through Figure 16. Cross section 2412+10 surveys between 2003 and 2012 (Figure 11) show deep scour along the right bank as a result of high flows between 2006 and 2011. Cross section surveys justify Patch 2 as an ideal location for a coarse sediment recruitment location to supply coarse sediment to downstream patches. Cross sections 2394+00 (Figure 12) and 1395+90 (Figure 13) shows changes to Patches 5 and 6 as a result of Phase II construction activities. At cross section 2394+00 no change between 2005 and 2012 to the thalweg elevation even though Patch 6 provided the access route to Patch 8. This is important as any increase in the riffle control elevation at Patch 6 would have impacted upstream riffle function.

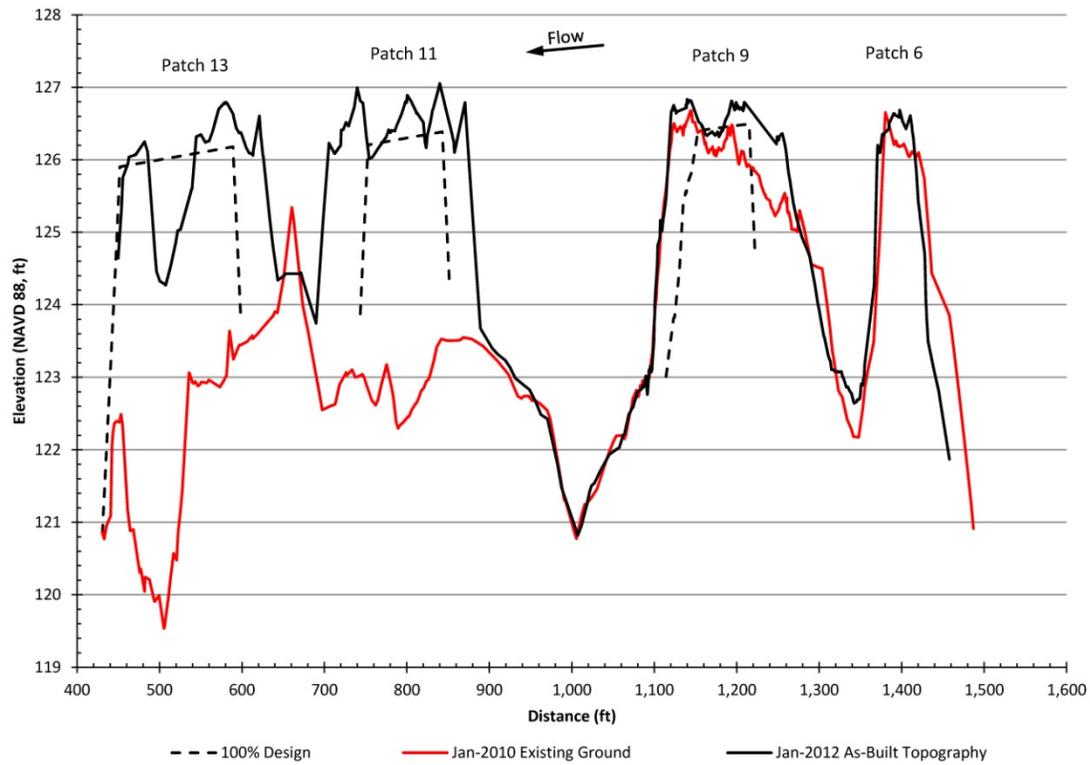
Figure 14. Longitudinal profile between Patch 6 and Patch 14 comparing existing, final design, and as-built conditions.

Phase II design riffle control elevation difference between Patches 9 and 13 was approximately 0.5 feet (M&T 2011). A grade check of the riffle control elevation at Patch 9, prior to construction, showed that 2011 high flows had increased the riffle control elevation to design grade therefore, no additional coarse sediment was added to Patch 9. Patches 6 through 13, Pre- and post-construction longitudinal profiles were pulled from DTM's with a 1-foot contour accuracy therefore, riffle crest elevations in Figure 14 are approximate. However, photopoint monitoring (Section 3.3) indicates no backwater effects on upstream riffles from downstream riffle crests. Figure 14 and Figure 16 capture some of the microtopographic features (dunes) incorporated into Riffle 21 and Patches 11 and 13. These constructed dunes provide immediate habitat benefits for juvenile salmonids (CMC 2001, CMC 2002, and DWR 2006).

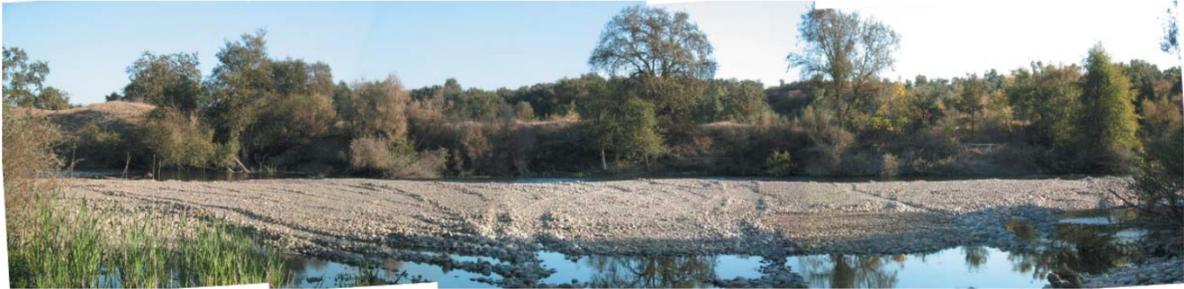
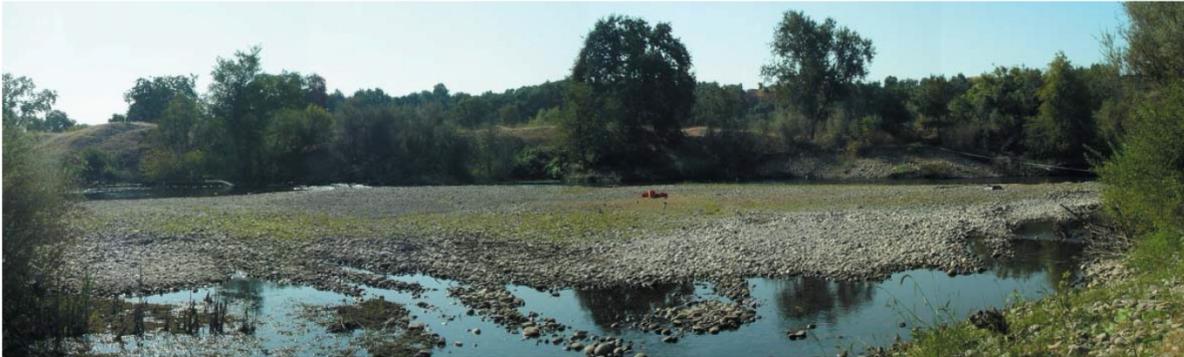
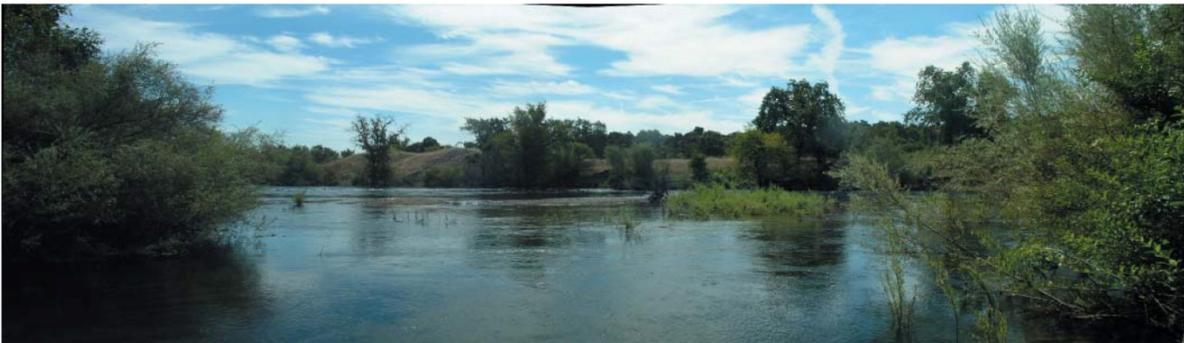
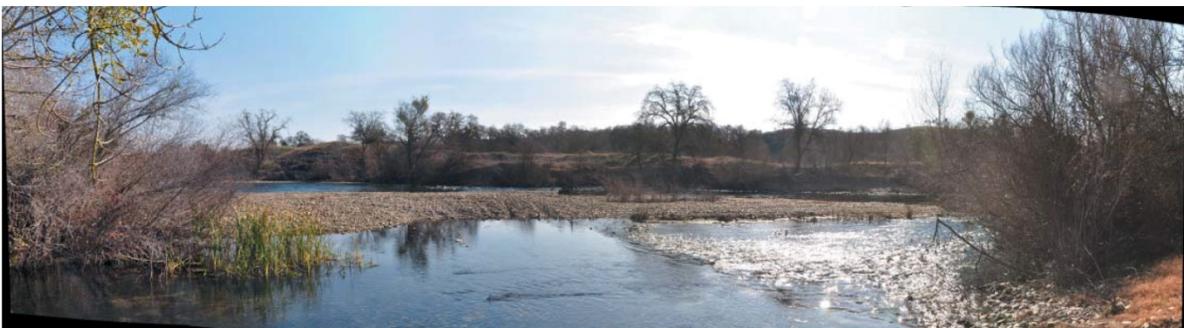
Figure 19. Photopoint #4 located at the backside of Patch 5, looking from the right bank across Patch 5 to the left bank.

Phase I: Post-construction monitoring photopoint #4 10-13-05 looking from right bank across Patch 5 to left bank.

Phase I: Post-2006 high flow monitoring photopoint #4 9-12-06 looking from right bank across Patch 5 to left bank.

Phase II: Pre-2011 construction monitoring photopoint #4 8-12-2011 looking from right bank across Patch 5 to left bank.

Phase II: Post-2011 construction monitoring photopoint #4 1-18-12 looking from right bank across Patch 5 to left bank.

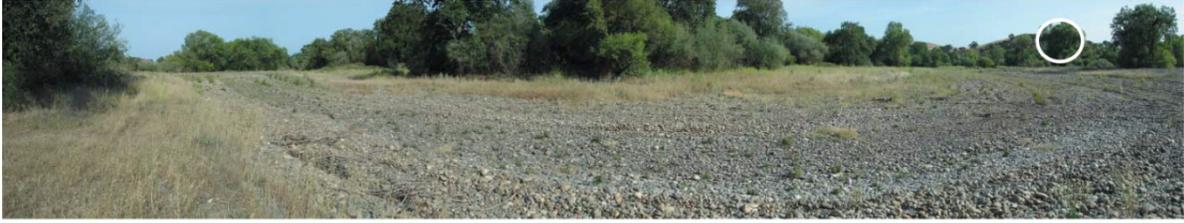
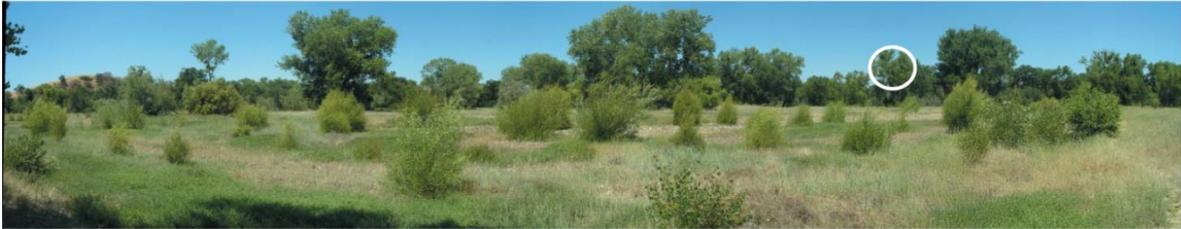
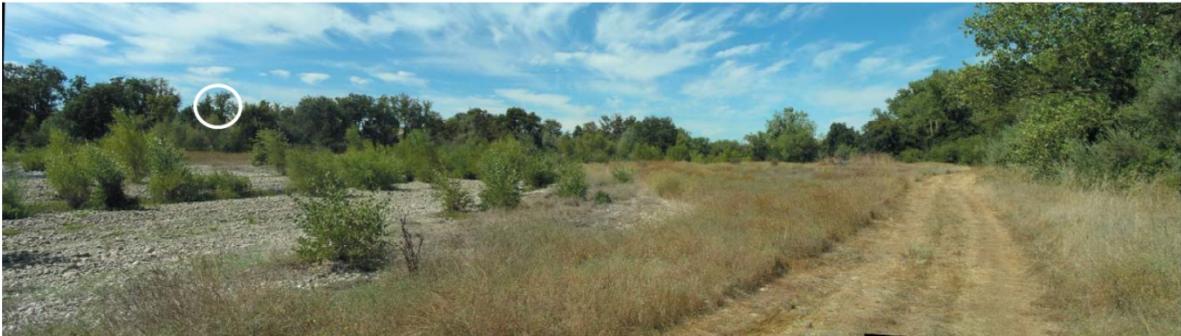
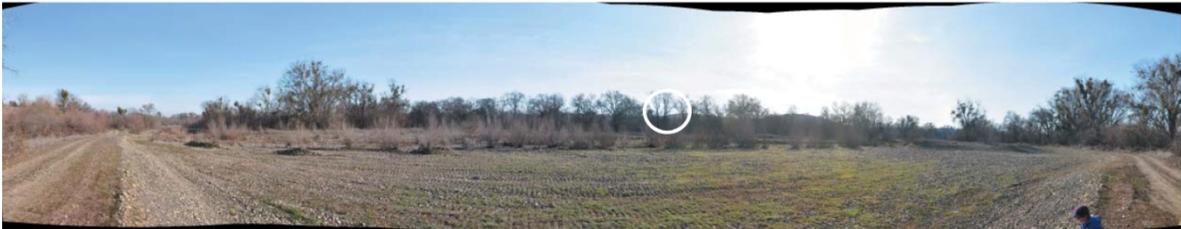
Figure 22. Photopoint #6 located along the right bank floodplain between Borrow Area 4 and the primary access road. Photo is taken looking toward the Tuolumne River.

Phase I: 2007 monitoring of photopoint #6 9-22-2007 looking at the Phase I floodplain to the left of Borrow Area 4.

Phase I: 2009 monitoring photopoint #6 6-25-2009 looking at the Phase I floodplain to the left of Borrow Area 4.

Phase II: Pre-2011 construction monitoring upstream of photopoint #6 8-12-2011 looking downstream along right bank floodplain at Borrow Area 4.

Phase II: Post-2011 construction monitoring photopoint #6 1-18-12 looking from the right bank across Borrow Area 4 to the Phase I floodplain.

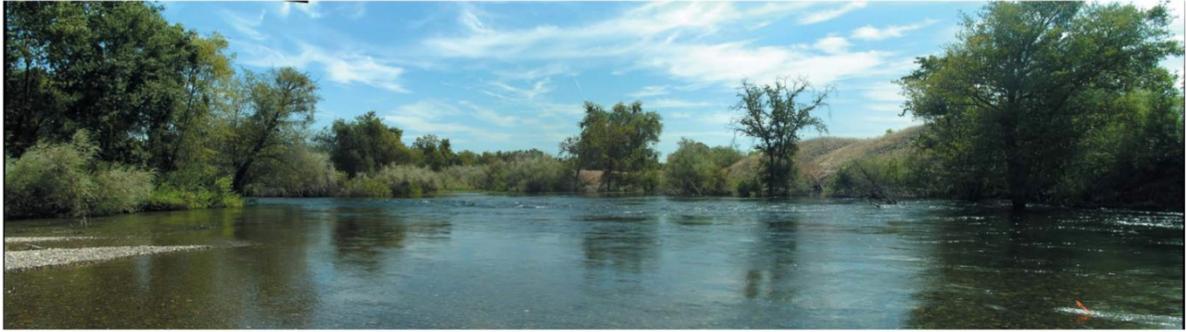
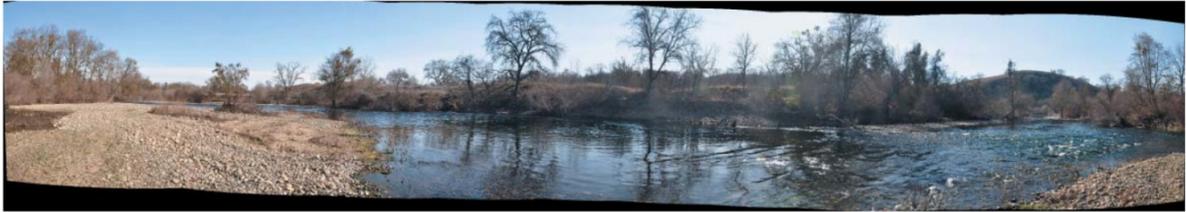
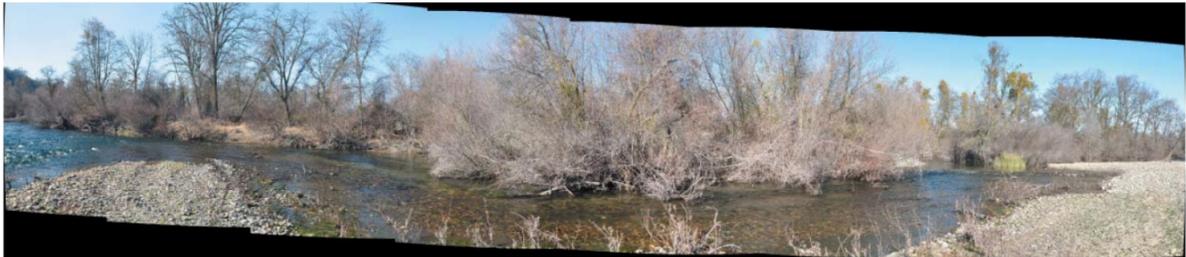
Phase II: Pre-2011 construction monitoring photopoint #7 8-12-2011 looking from right to left bank from Patch 8 to Patches 7A and 7B.

Phase II: Post-2011 construction monitoring photopoint #7 1-18-12 looking from right to left bank from Patch 8 to Patches 7A and 7B.

Phase II: Post-2011 construction monitoring photopoint #7 1-18-12 looking at the side channel between Patch 5 and the right bank.

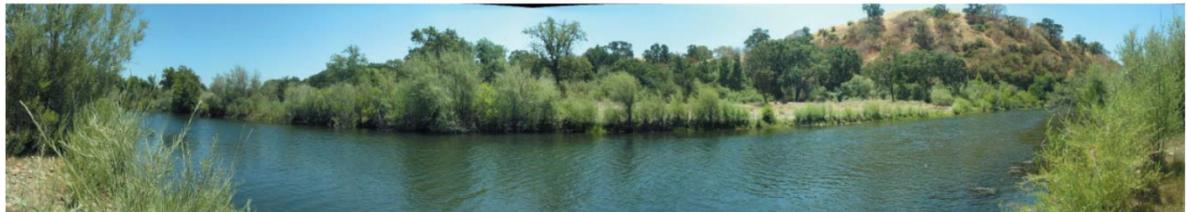
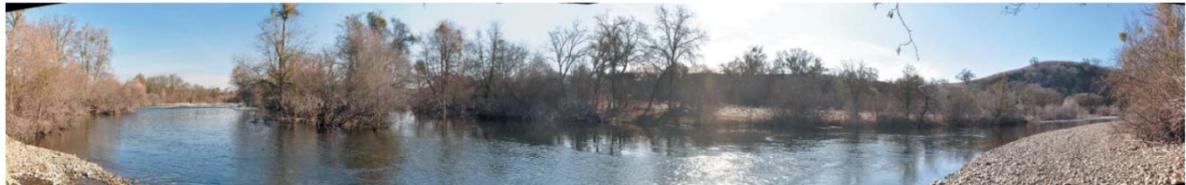
Figure 24. Photopoint #8 is located on Patch 10 looking from right to left bank at Patches 9 to 14. The pre-2011 construction photo was taken from the right bank across from Patch 12.

Photopoint	Summary of results
1	Patch 2 panoramas show the Phase I as-built condition, the results of flows in excess of 6,000 cfs in 2006, and Phase II as-built conditions. Visually, as-built Phase II conditions closely match Phase I conditions (Figure 18).
2 and 3	See Section 4 of this report for details.
4, 5, and 7	These three photopoints document the conversion of a large in-channel gravel pit to a channel geometry scaled to the contemporary flow regime. Photos begin with Phase I as-built conditions and end with Phase II as-built conditions (Figure 19, Figure 20, Figure 21, and Figure 23).
6	The 2007 panorama shows the Phase I floodplain one year after cuttings were planted and again in 2011 with much improved growth. The Phase II as-built panorama shows the newly construction floodplain in the foreground without plantings (Figure 22).
8, 9, and 10	Photographs document Patches 9 through 14 and show pre-construction channel conditions to be relatively uniform, almost rectangular in shape, with no coarse sediment visible between the left and right banks of the channel. The January 2012 photos show alternating bars, pools, and riffles as a result of Phase II construction of Patches 10 through 14 (Figure 24 through Figure 26).

Phase II: Pre-2011 construction monitoring approximately 300 ft downstream of photopoint #8 6-29-2009 looking from right to left bank at Patches 9-14.

Phase II: Post-2011 construction monitoring photopoint #8 1-18-12 looking from right to right bank to left bank at Patches 9-14.

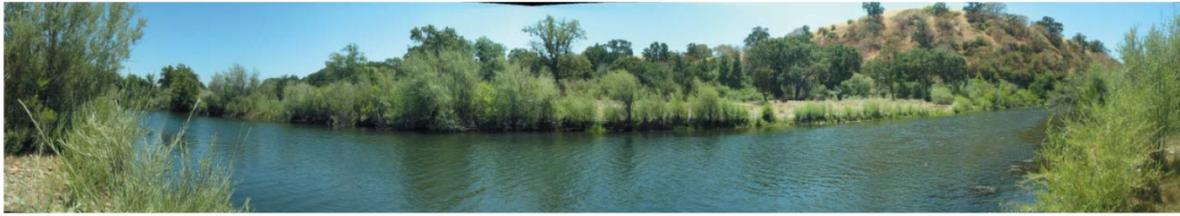
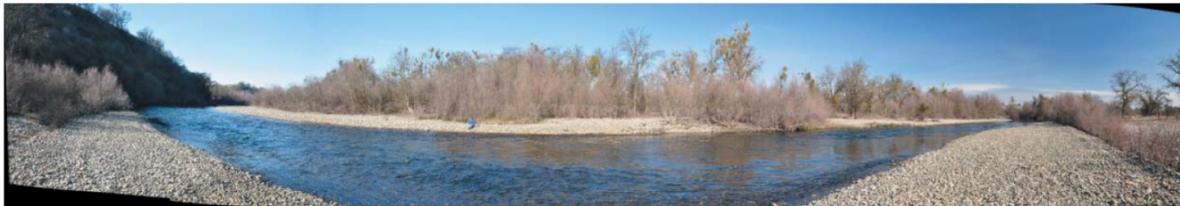
Figure 25. Photopoint #9 is located on Patch 12 looking from left to right bank at Patches 9 to 14. The pre-2011 construction photo was taken from the right bank across from Patch 12.

Phase II: Pre-2011 construction monitoring opposite bank from photopoint #9 6-29-2009 looking from right to left bank at Patches 9-14.

Phase II: Post-2011 construction monitoring photopoint #9 1-18-12 looking from left to right bank at Patches 9-14.

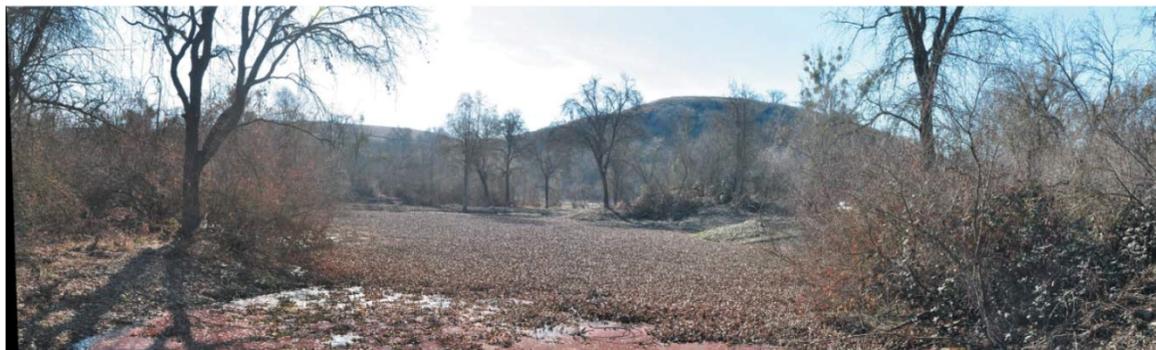
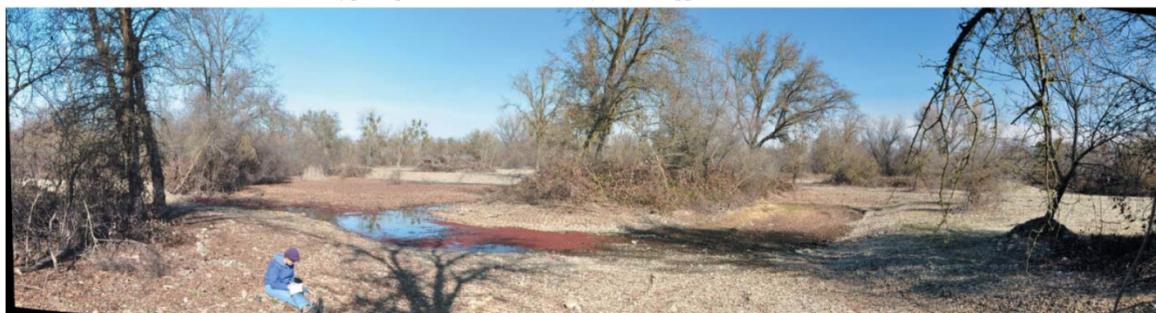
Figure 27. Photopoint #11 is located between the constructed off-channel wetlands, showing integration into the surrounding constructed floodplains.

11	Two photographs document as-built Phase II conditions of the off-channel gravel pits (now wetland ponds) enhancement areas (Figure 27).
12	Photos taken at the upstream end of the Phase I floodplain show the rapid growth of riparian cuttings planted in 2006 and minor road impact as a result of Phase II construction (Figure 28).
13	Photopoint 13 was established at the upstream end of the Phase I project area to document baseline conditions upstream of Patch I and into the upper end of Duck Slough for future Phases of construction at Bobcat Flat (Figure 29).

Phase II: Post-2011 construction monitoring photopoint #11 1-18-12 looking into the lower constructed off-channel wetland.

Phase II: Post-2011 construction monitoring photopoint #11 1-18-12 looking into the upper constructed off-channel wetland.

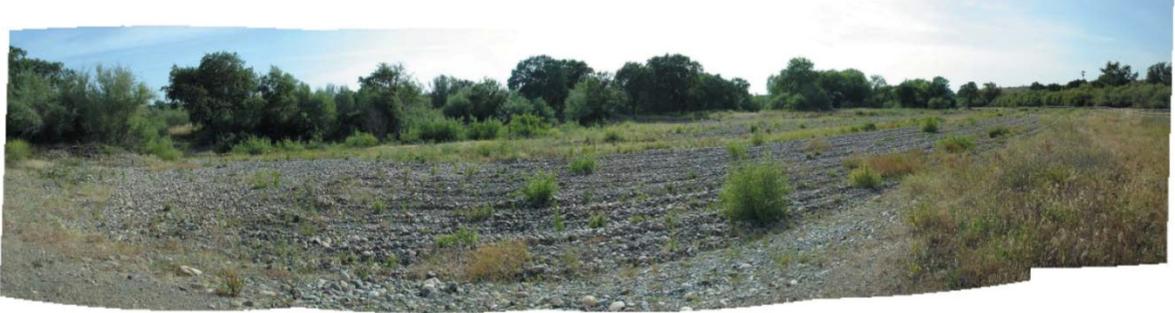
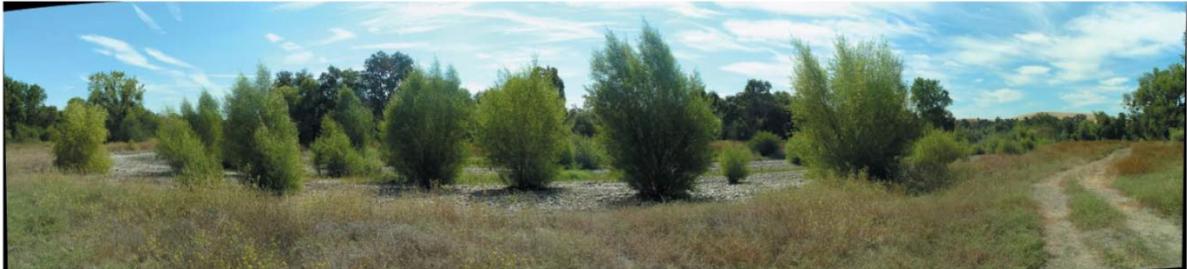
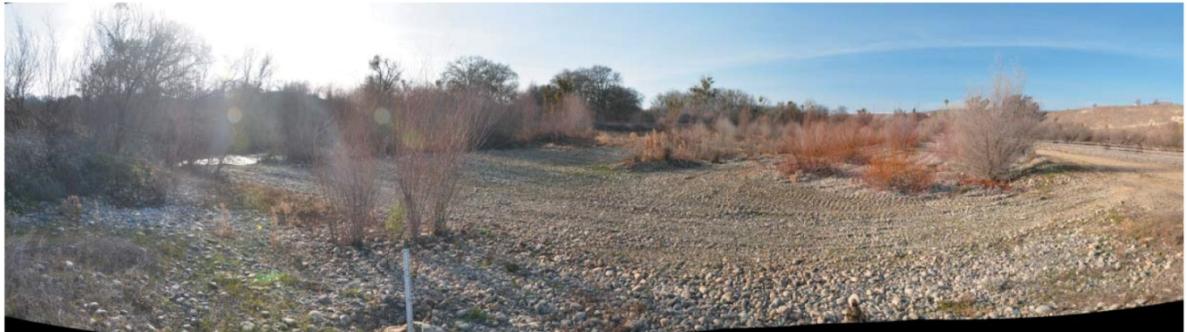
Phase I: 2007 monitoring at photopoint #12 9-22-2007 looking downstream at the Phase I floodplain.

Phase II: Pre-2011 construction monitoring 200 ft to the right of photopoint #12 8-12-2011 looking downstream at the Phase I floodplain.

Phase II: Post-2011 construction monitoring photopoint #12 1-18-12 looking downstream at the Phase I floodplain.

Figure 28. Photopoint #12 is located at the upstream end of the Phase I floodplain cut. Riparian cuttings were planted in the summer due to high flows late into the spring.

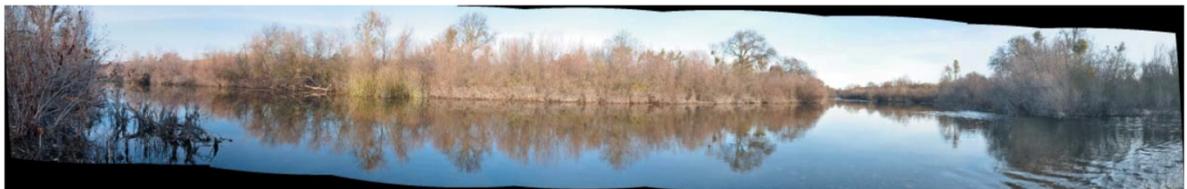
Phase II: Post-2011 construction monitoring photopoint #13 1-18-12 looking downstream into Duck Slough (left side of photo) and upstream into mainstem channel.

Figure 29. Photopoint #13 on the right bank pin cross section 2413+20. This photograph documents the upper end of Duck Slough and the large pool upstream of Patch 1. Both of these areas are part of the a long-term restoration plan for Bobcat Flat (M&T 2011).

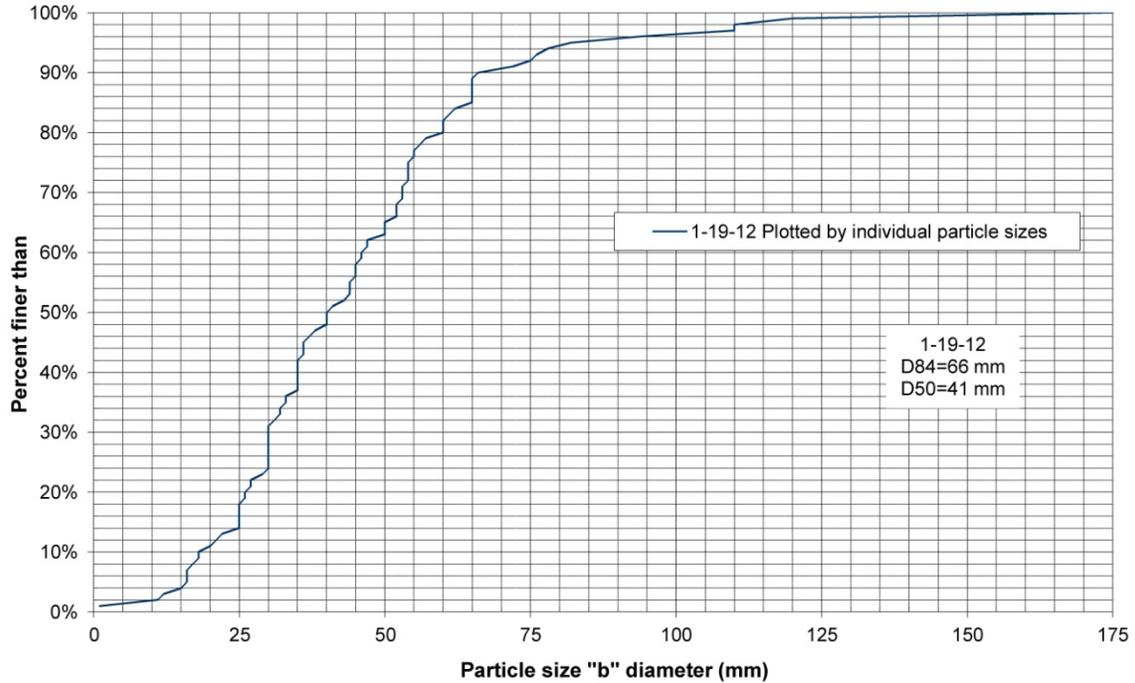
As-built monitoring pebble counts at Patches 2 and 10 were ranked by grain size and plotted (Figure 30 and Figure 31). A comparison of Phase I (2005) and Phase II (2012) Patch 2 as-built pebble counts indicates that above the 35 mm particle size, coarse sediment placed in 2012 was finer than that placed in 2005 (Figure 30). This change is a direct result of the use of 4 in x 4 in square screen during Phase II construction as opposed to the 5 in x 5 in screen used during Phase I construction. The Bobcat Flat RM 43 – Phase I As-Built Monitoring Final Report recommended the use of a 4 in x 4 in screen for future Bobcat Flat restoration phases (M&T 2006a).

Figure 31. Pebble count results Phase II, Patch 10.

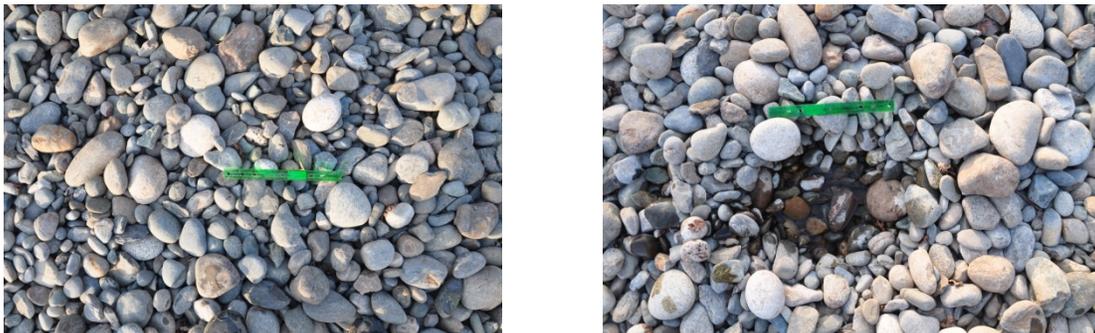
Figure 32. Pre- and post-shovel excavation at one of the sub-sampling locations Phase I, Patch 2.

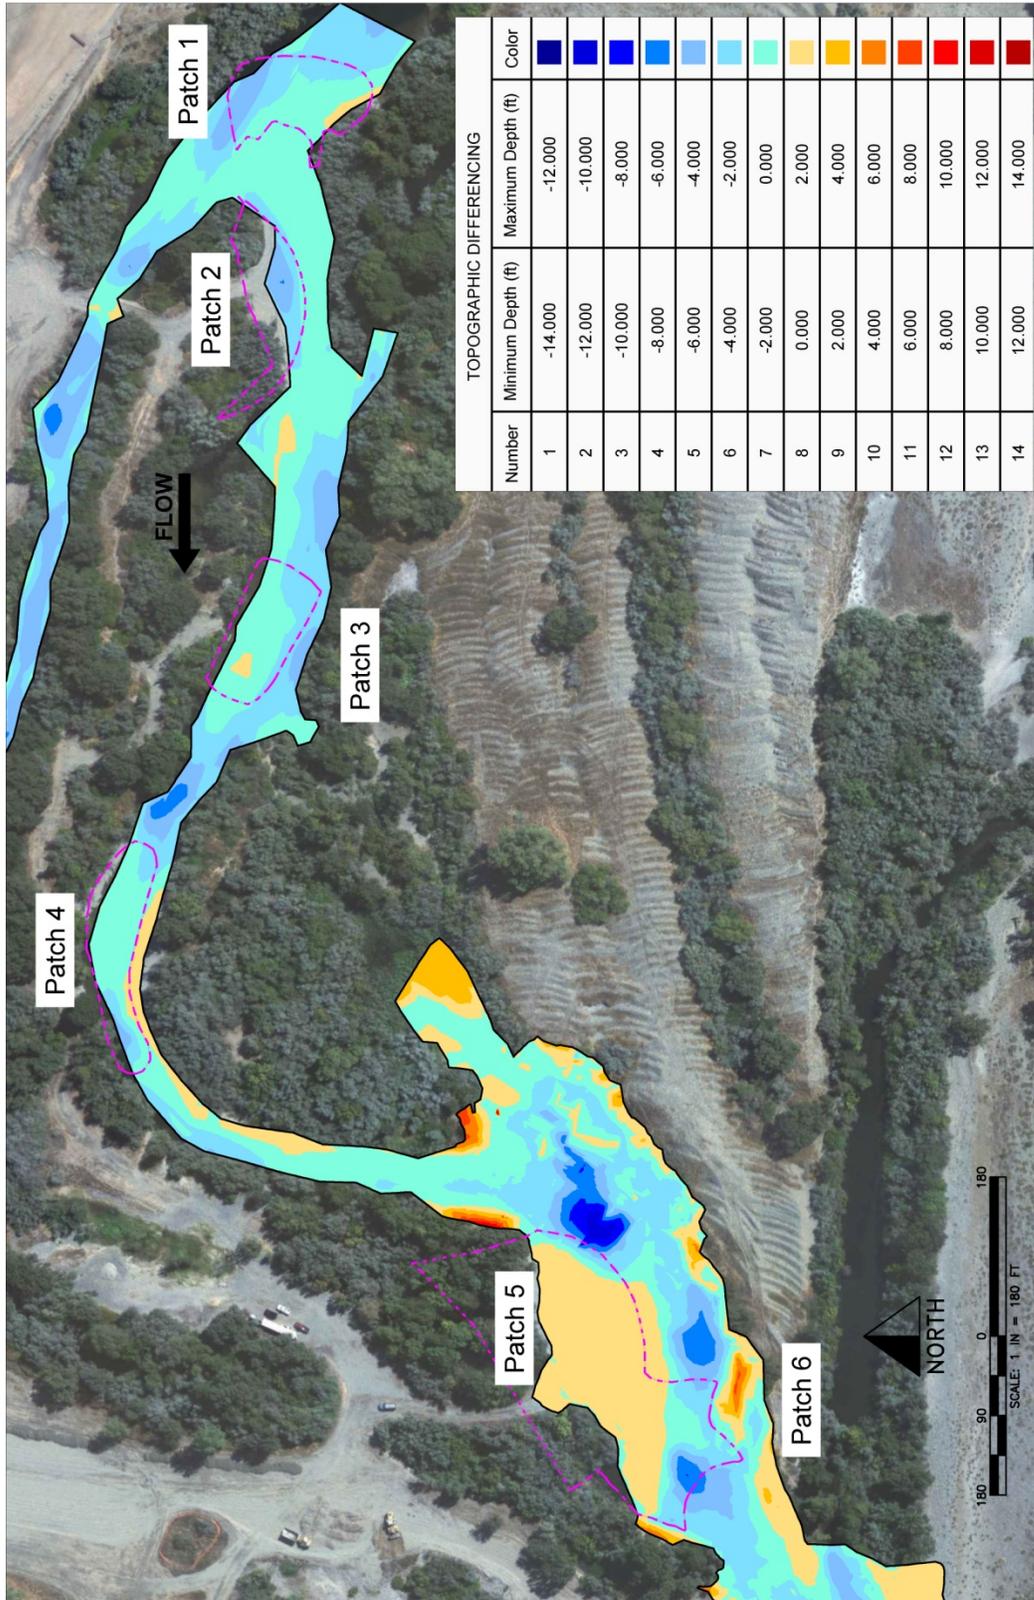
Figure 38. Depth of the May 2011 ground surface above and below the September 2005, approximately 250 cfs, water surface elevation.

Response: Monitoring of Phase I coarse sediment additions (Patches 1 through 6) indicated that pools and runs and overall channel complexity persists in 2011 (Figure 38). Figure 38 shows pools in excess of 10 ft deep and runs 6 ft to 8 ft deep. Further, the addition of coarse sediment, in combination with high flows, has begun to erode channel banks, and recruit trees and coarse sediment into the mainstem channel (Figure 47). The large alder recruited by high flows in 2011 (Figure 47) has induced sediment deposition upstream and scour adjacent to and downstream of the fallen tree (Figure 37).

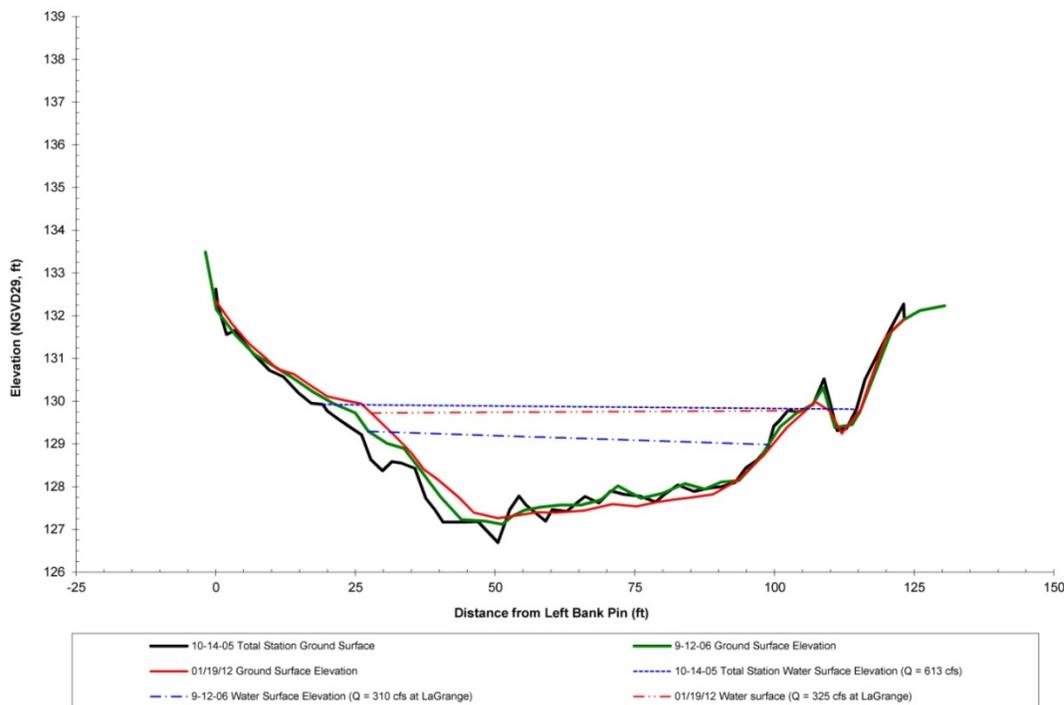
Cross section 2403+95 at Patch 4 (Figure 2), showed little change to the bed topography with up to 1 ft of deposition along the right bank constructed point bar (Figure 39). Cross section 2408+10 at Patch 3 (Figure 2), showed approximately 1 ft of deposition through the cross section below the surveyed water surface elevations (Figure 40). This cross section surveys may indicate that sediment supply is in balance through Patch 4 and that the channel geometry at Patch 3 has reached equilibrium, with deposition occurring uniformly across the active channel. However, deposition at Patch 3 may also indicate that the mainstem channel is continuing to adjust vertically, using coarse sediment supplied by Phase I construction and bank scour (Figure 37) to redistribute in-channel slope between Riffles 20 and 21.

Figure 39. Cross section 2403+95, Patch 4, monitoring results from October 2005 (post-Phase I construction) and January 2012.

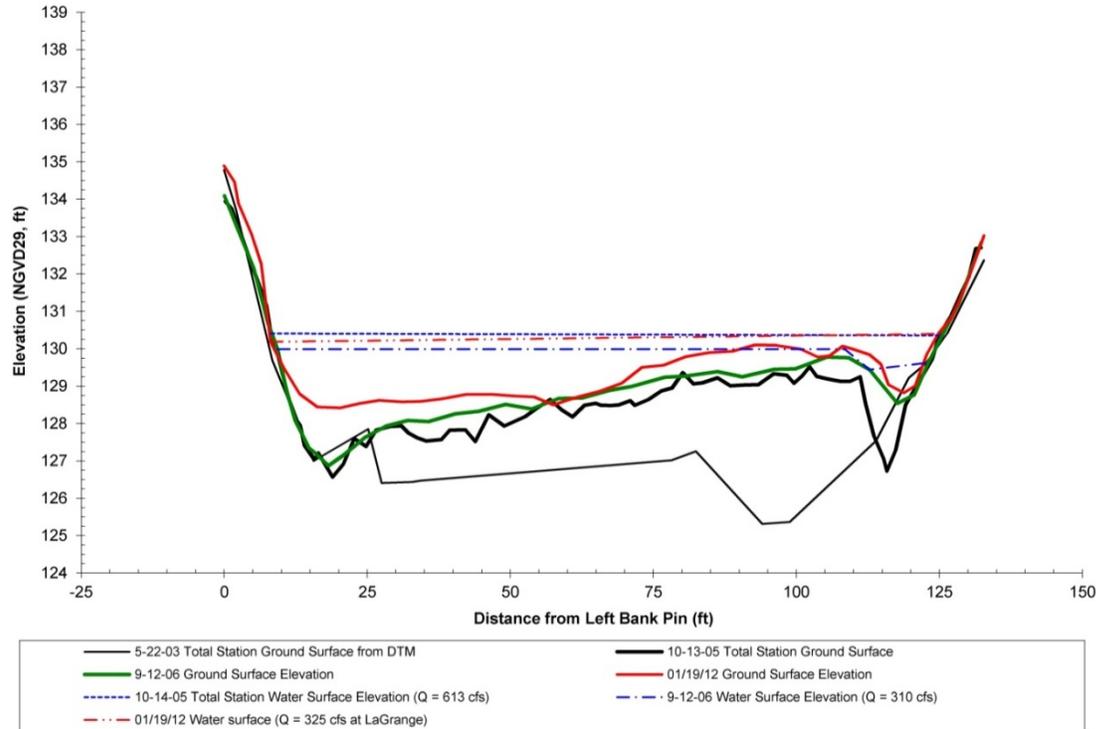
Figure 40. Cross section 2408+10, Patch 3, monitoring results from May 2003 (pre-Phase I construction), September 2006 post-Phase I construction, and January 2012.

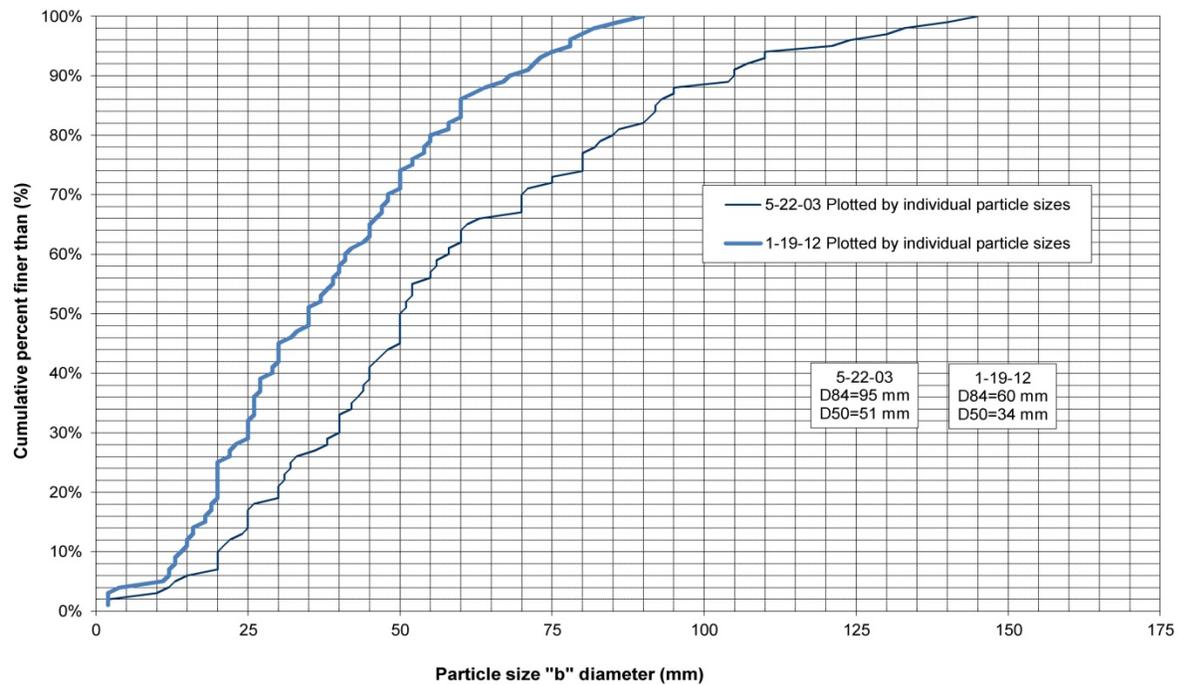
As-built monitoring pebble counts at cross section 2412+90 in Riffle 20 (Figure 41), and Patch 3 (Figure 42) were ranked by grain size and plotted. A comparison of pebble counts at Riffle 20 showed a fining of the surface grain size with the D_{84} and D_{50} particle sizes decreasing from 95 mm (3.75 in) to 60 mm (2.4 in) and 51 mm (2 in) to 34 mm (1.33 in) respectively (Figure 41). Results are similar at Patch 3 with the D_{84} and D_{50} surface particle sizes decreasing from 83 mm (3.25 in) to 57 mm (2.25 in) and 56 mm (2.2 in) to 35 mm (1.4 in) respectively (Figure 42). Results also showed that only 5% of the surface grain size is less than 10 mm (0.4 in) (Figure 41 and Figure 42).

Figure 41. Summary of Riffle 20, cross section 2412+90 pebble count results starting with pre-Phase I construction in May 2003 and ending with post-Phase II construction in January 2012.

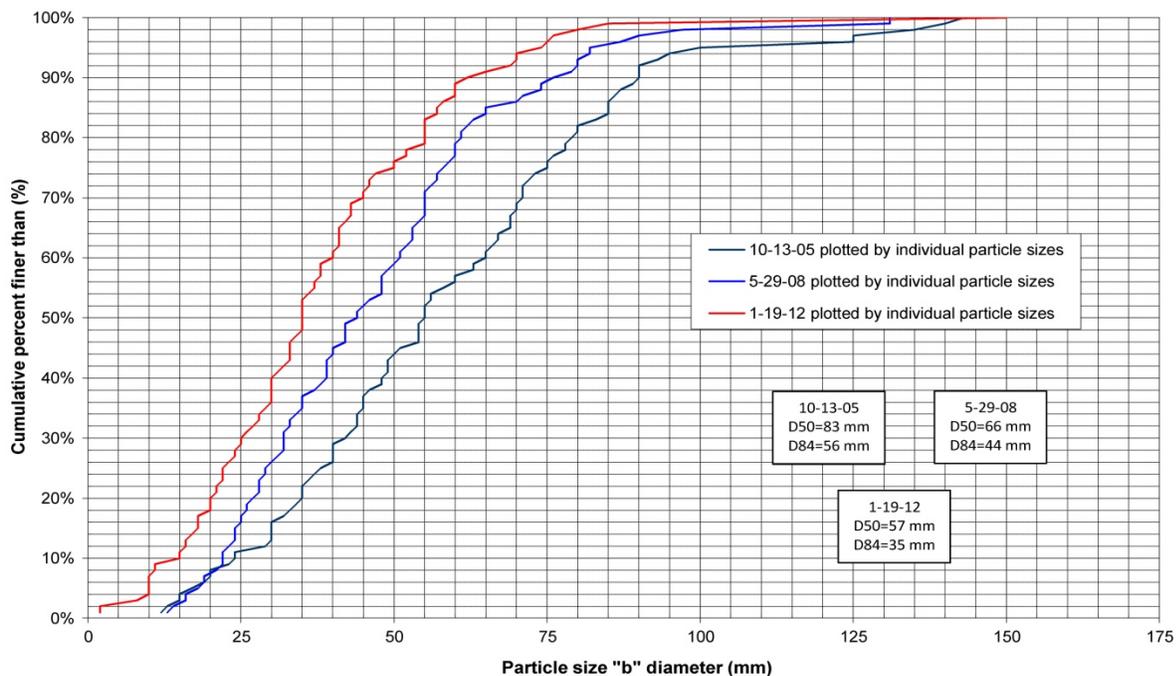
Figure 42. Summary of Patch 3 pebble count results starting with post-Phase I construction in October, 2005 and ending with post-Phase II construction in January 2012.

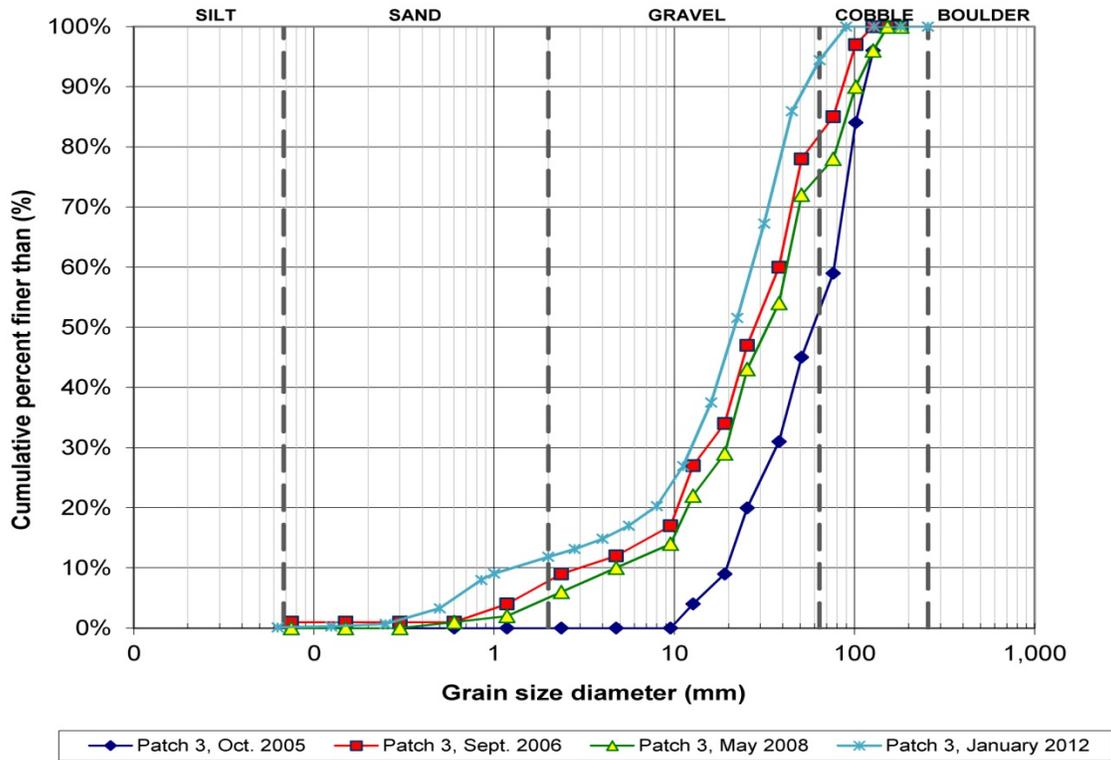
The bulk samples taken at Patch 3 showed an overall fining of material with a grain size distribution in October 2005 (Phase I as-built) of 0% sand (0.07 mm to 2 mm), 55% gravel (2 mm to 64 mm) and 45% cobble (64 mm to 300 mm), and in January 2012 of 12% sand, 82% gravel and 6% cobble

Figure 43. Summary of Patch 3 bulk sampling results starting with post-Phase I construction in October, 2005 and ending with post-Phase II construction in January 2012.

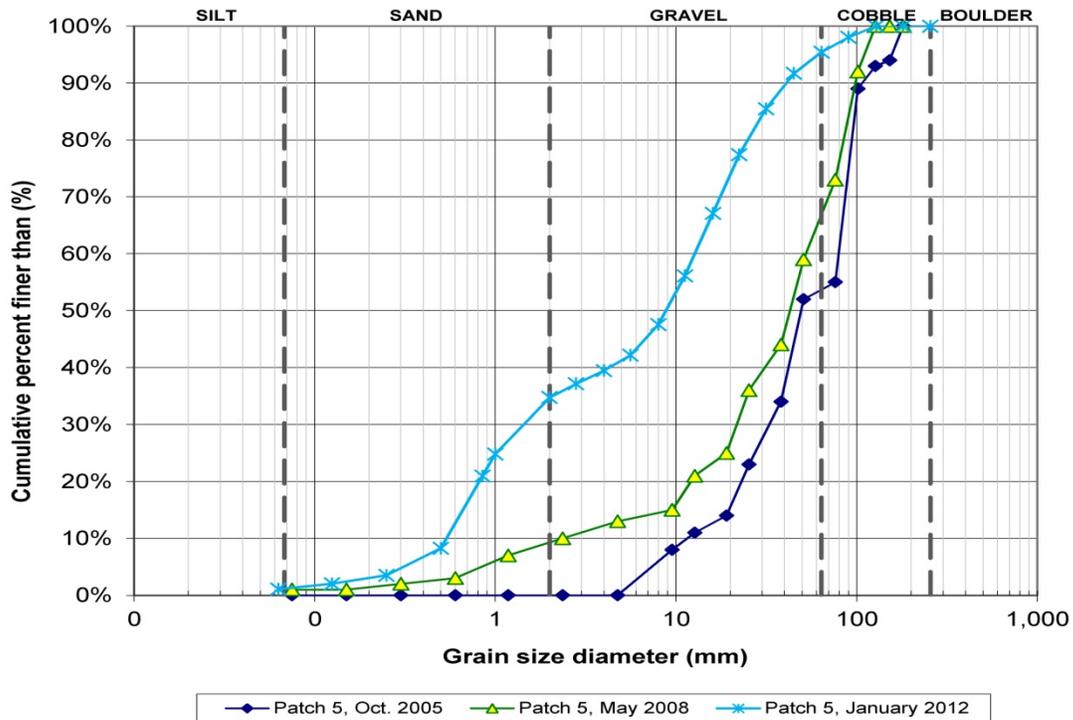
(Figure 43). Bulk sample results at Patch 5 showed a much more substantial fining of grain size distribution between October 2005 (Phase I as-built) and January 2012. Coarse sediment distribution in October 2005 consisted of 0% sand, 55% gravel, and 45% cobble, and in January 2012 of 35% sand, 60% gravel and 5% cobble (Figure 44).

Figure 44. Summary of Patch 5 bulk sampling results starting with post-Phase I construction in October, 2005 and ending with post-Phase II construction in January 2012.

Monitoring of the Phase I project over the past seven years indicates that fine sediment is depositing into coarse sediment augmentation patches within the mainstem channel; however, egg survival remains high. Over the same period, the rescaling of a large in-channel gravel pit (Patch 5) has resulted in approximately 2 feet of deposition, comprised mostly of fines (Figure 44), outside the low flow channel.
