Bobcat Flat RM 43 Phase II As-Built Monitoring Final Report

**Bobcat Flat RM 43 Phase II
As-Built Monitoring Final Report
(Including Phase I Monitoring and Analysis)**

Friends of the Tuolumne, Inc.
1900 NE 3rd Street, Suite 106#314
Bend, OR 97701

McBain and Trush, Inc.
P.O. Box 663
Arcata, CA 95518

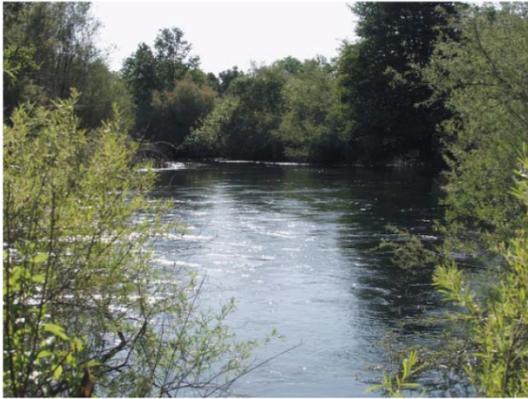
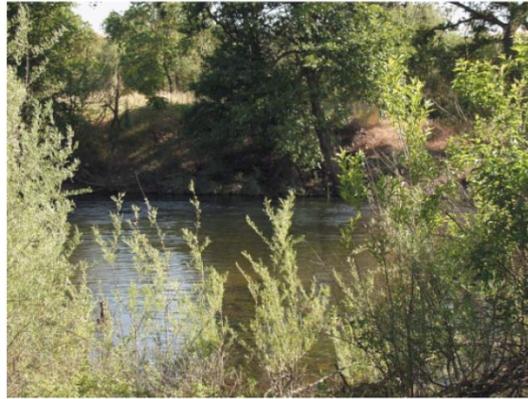
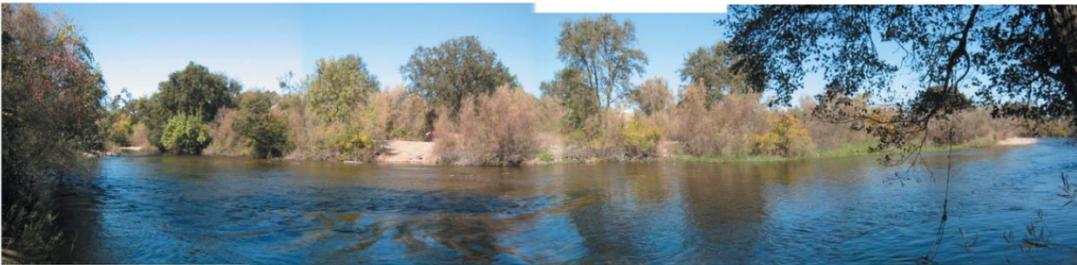
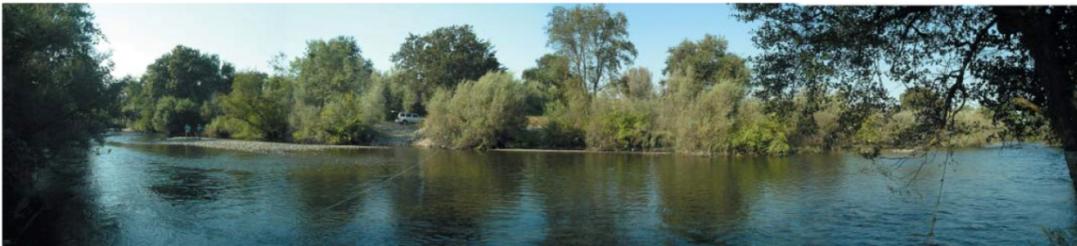
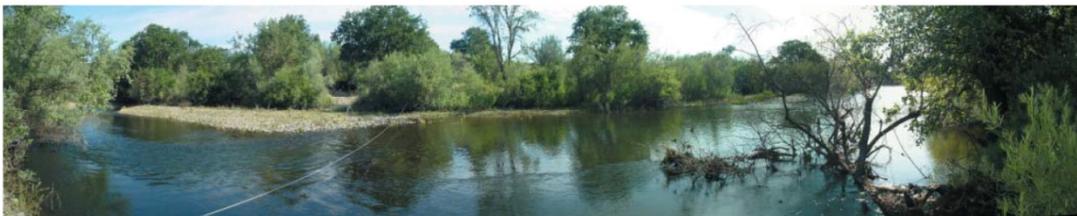
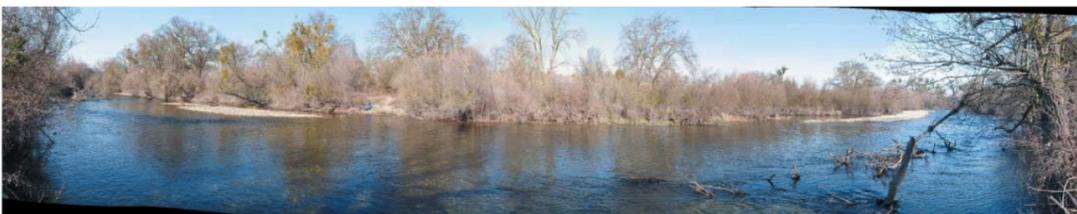
Photopoint monitoring results for Photopoints 2 and 3 are presented in Figure 45 and Figure 46. Photopoint #2 showed the deposition of coarse sediment in the form of a medial bar between October 2005 and September 2006. In addition, a large tree along the left bank was recruited into the river between September 2006 and May 2008 indicating lateral scour along the left bank toe. Photopoint #3 showed reworking of the coarse sediment between October 2005 and January 2012 with no obvious change in coarse sediment storage or channel geometry. A large alder along the right bank (top left of each photograph from October 2005 to May 2008) was recruited into the river between May of 2008 and January 2012. This indicates lateral scour along the toe of the right bank and likely channel migration into the right bank.

Figure 45. Photopoint #2, located on the left bank across from Patch 3. Note the development of a medial bar and large wood recruitment as a result of high flows and coarse sediment additions.

Photo monitoring of Patch 3 (Figure 45) showed coarse sediment deposition as a medial bar between 2005 and 2006, likely a result of 2006 high flow recruitment and deposition of coarse sediment from Patch 2 and Patch 3. Patch 3 was sampled four times between October 2005 and January 2012 (Table 5) and showed a 14% increase in coarse sediment less than 10 mm between 2005 and 2006 (Figure 43). The Patch 3 bulk sample sieve results were used to calculate Chinook salmon and steelhead trout egg survival using equation(s) developed by Tappel and Bjornn (1983). The resulting analysis showed little to no change (+/- 2%) in the percent egg survival for Chinook salmon between 2005 and 2012 as a result of high flows and fine sediment deposition within Patch 3 (Figure 48). Egg survival results for steelhead trout are the same between 2005 and 2008; however, egg survival did decrease by 17.3% between 2008 and 2012 (Figure 48), likely due to the increase in fine sediment (Figure 43).

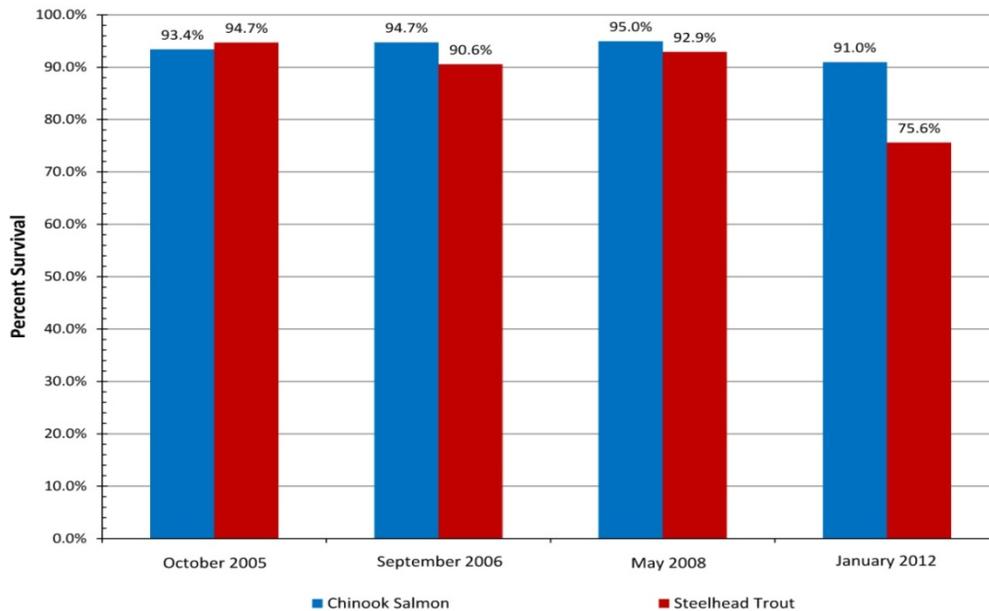
Figure 48. Chinook salmon and steelhead trout percent egg survival estimates at Phase I Patch 3, between October 2005 and January 2012 from Tappel and Bjornn (1983).
